## PROPERTY INSPECTION REPORT

**Prepared For:** Mr. Bill Sample Machner  
(Name of Client)

**Concerning:** 22 Park Blvd., Houston, TX, 77304  
(Address or Other Identification of Inspected Property)

**By:** Dan smithTREC # 20iii716 10/31/2013  
(Name and License Number of Inspector) (Date)

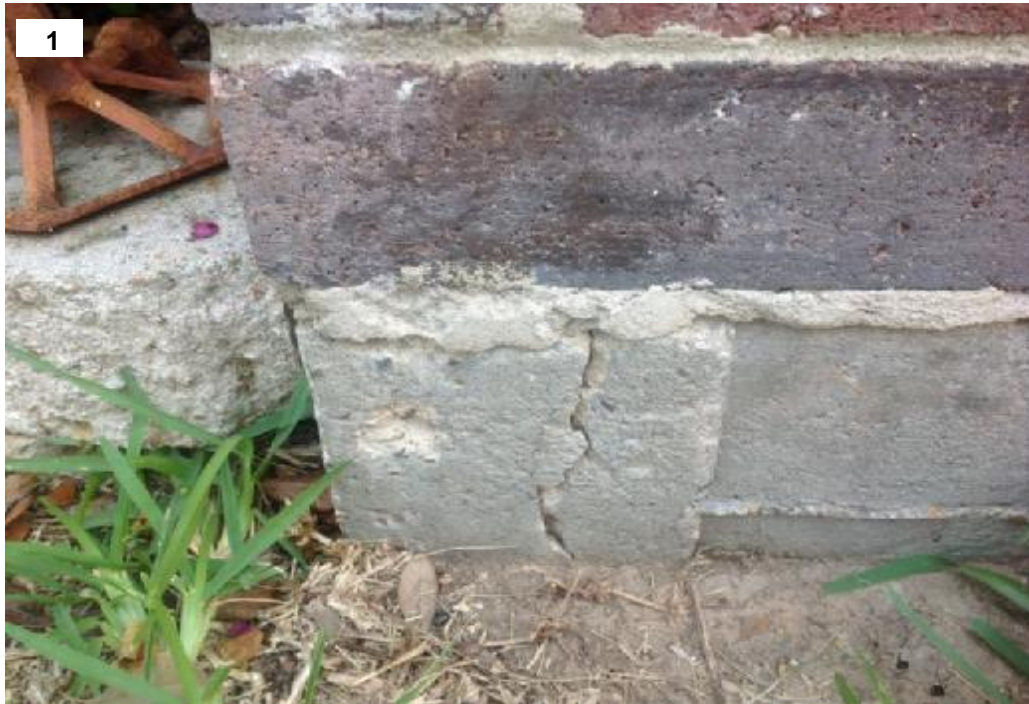
D - There are corner pops noted on the foundation. Corner pops are common on slab foundations and are not considered to be a major concern.

Corner pop  
Crack

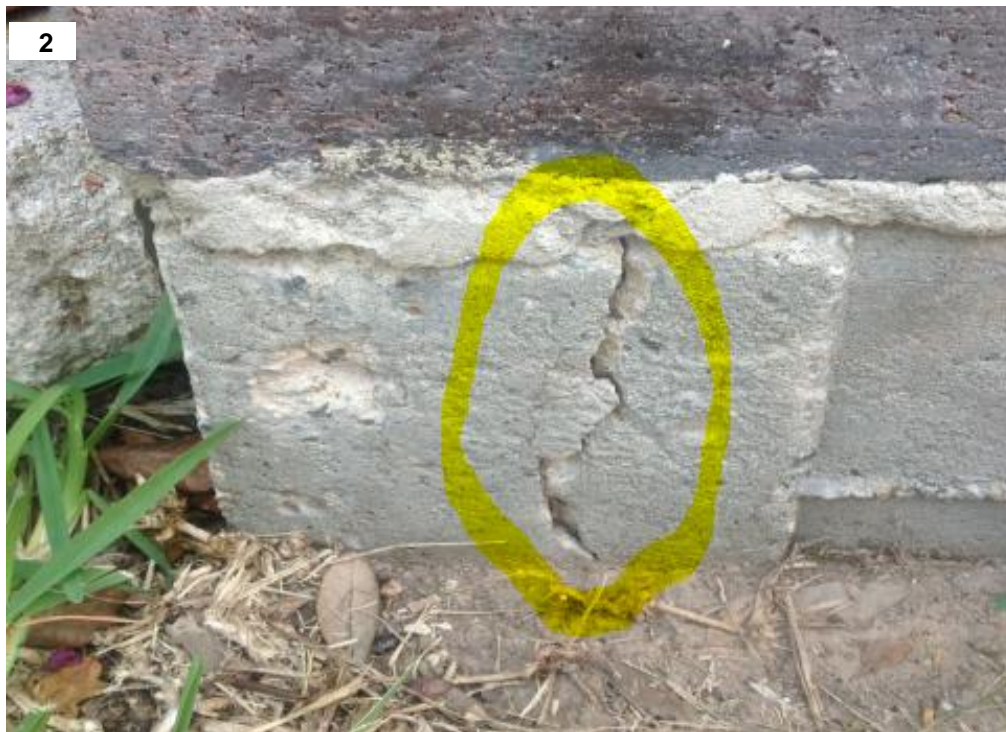
Corner pop  
Crack

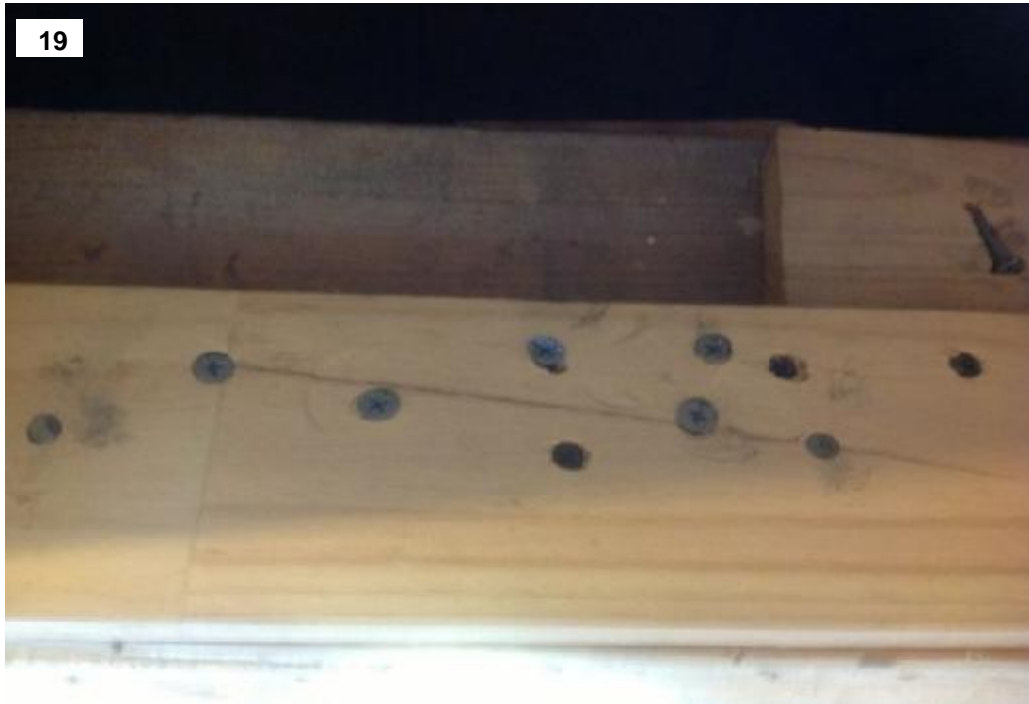
D - The pull-down attic stairway was not properly attached to the rough framing with 16d nails or 1/4" x 3" lag screws per manufacturer's recommendations. (4 each side 3 each end) This will void the manufacturer's warranty. This is a safety hazard.  
 D - There is an inadequate platform in front of water heater, HVAC system. This makes inspection, maintenance, and repair difficult and hazardous. A minimum of 30 inch of service platform is required along the entire front side of unit(s).

improper attachment of pull down stairs

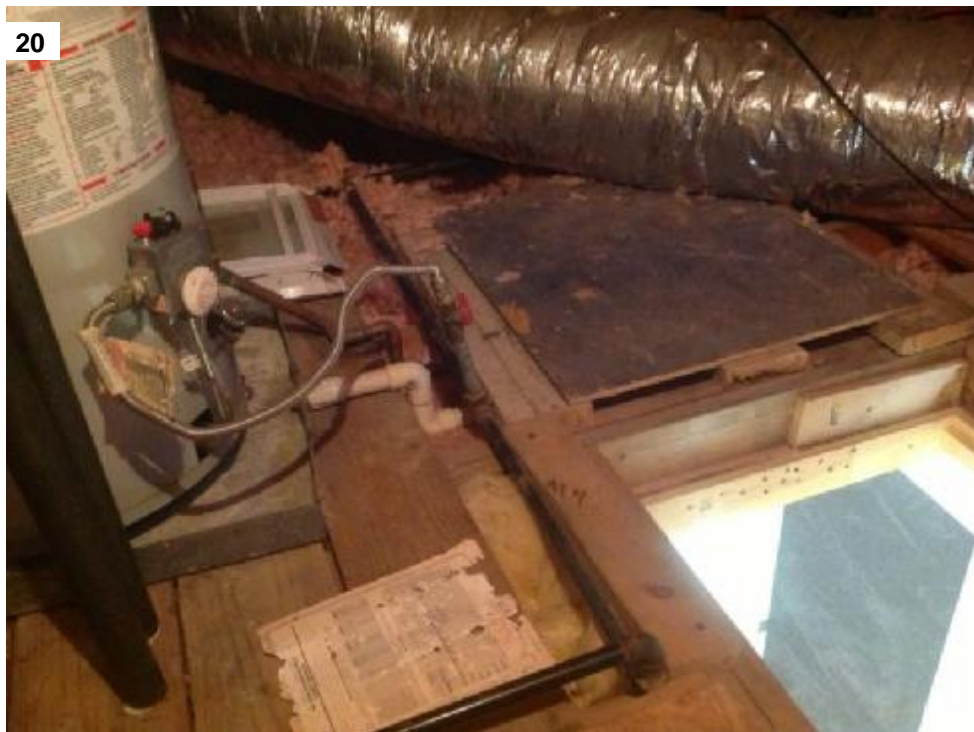
improper working platform in front of water heater

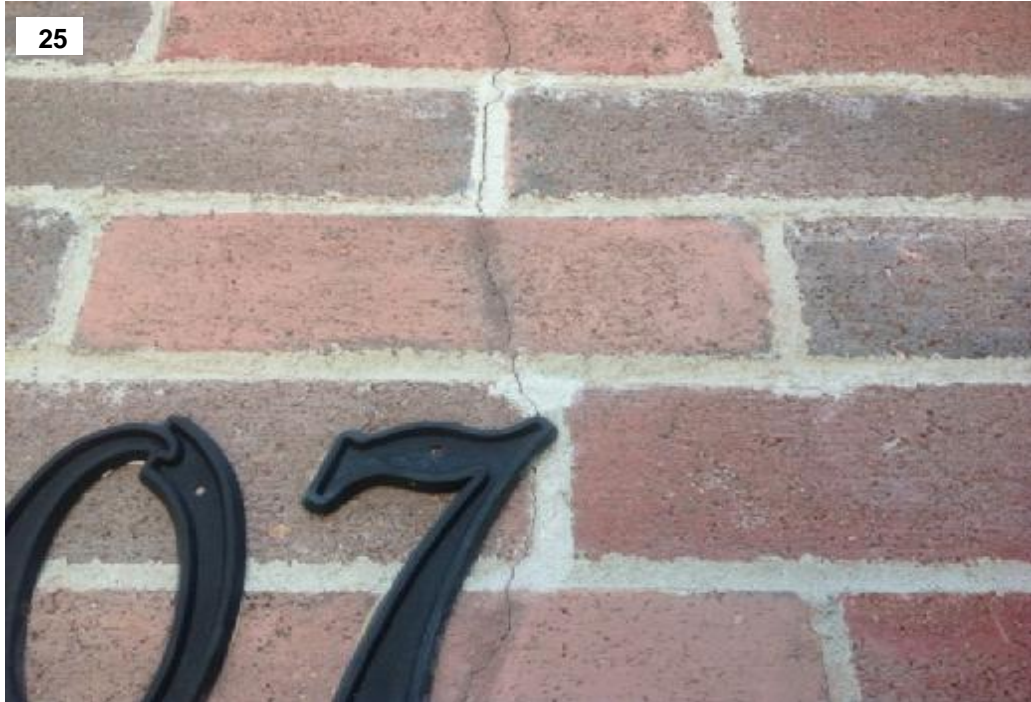
D - There were vertical cracks noted in the brick veneer. This type of crack is associated with lateral expansion and contraction due to extreme heat. Although this looks serious it does not indicate foundation movement. Recommend that a qualified contractor evaluate and repair as necessary.

Crack in brick veneer located above garage

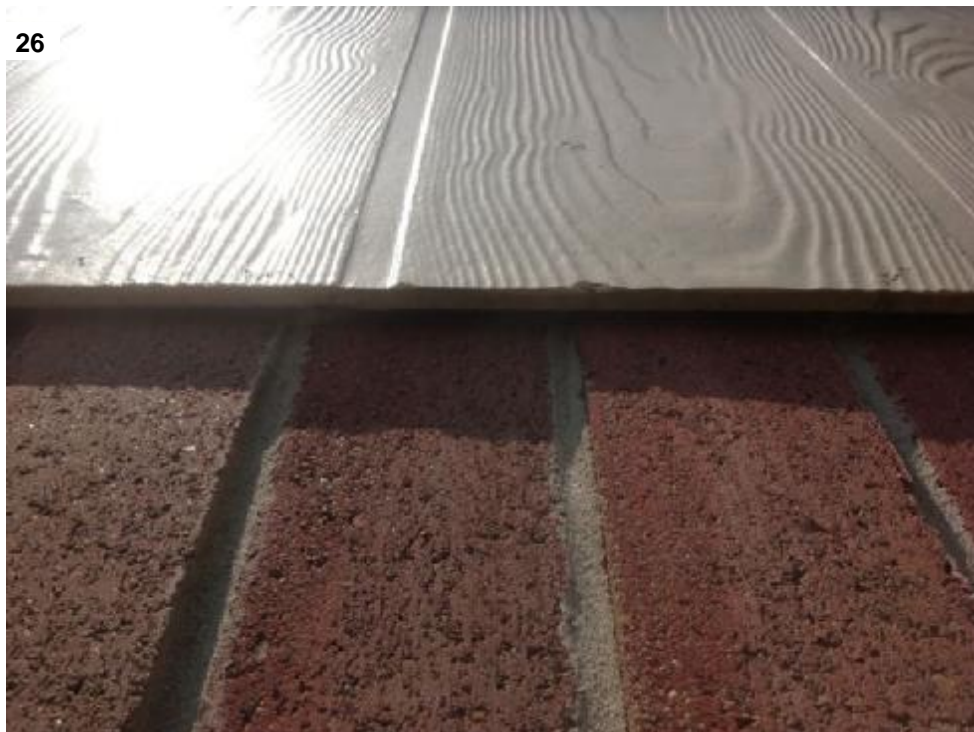
D - Caulk and seal all gaps, cracks, and openings. There are various areas around the house that need sealing to prevent water and insect intrusion.

siding to brick needs caulking

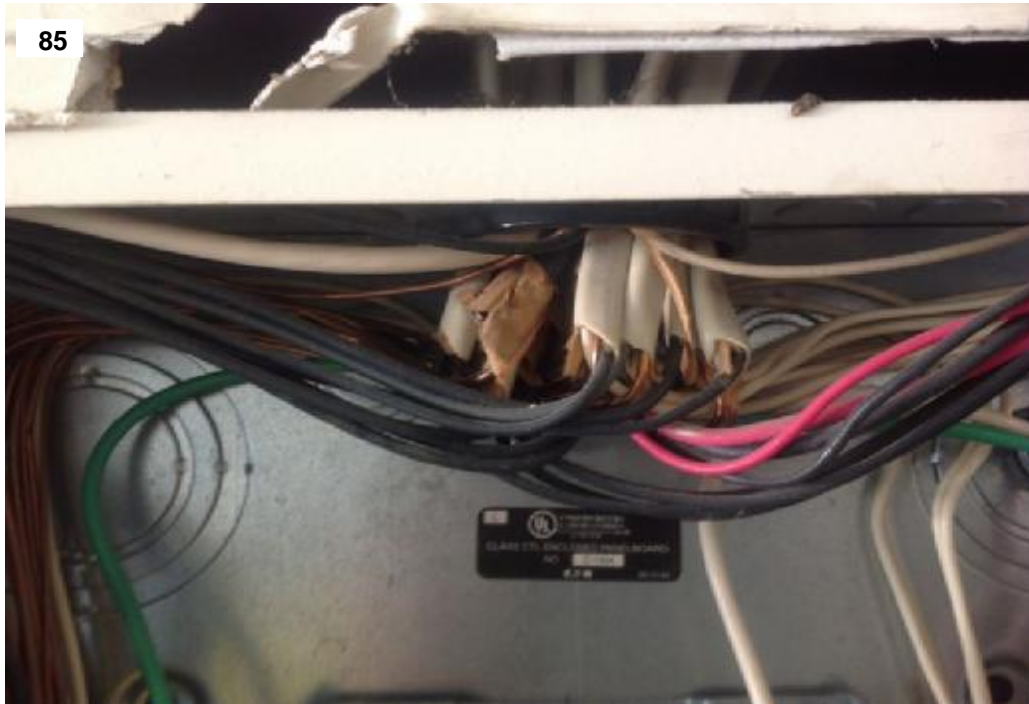
**D - Numerous branch circuit conductors are improperly entering the main electrical panel through a single large knockout located at the top of the panel box. Under current electrical standards, branch circuit conductors shall be evenly distributed and secured through the provided knockout holes. This does not comply with current fire regulations.**

Conductor wires entering one knockout

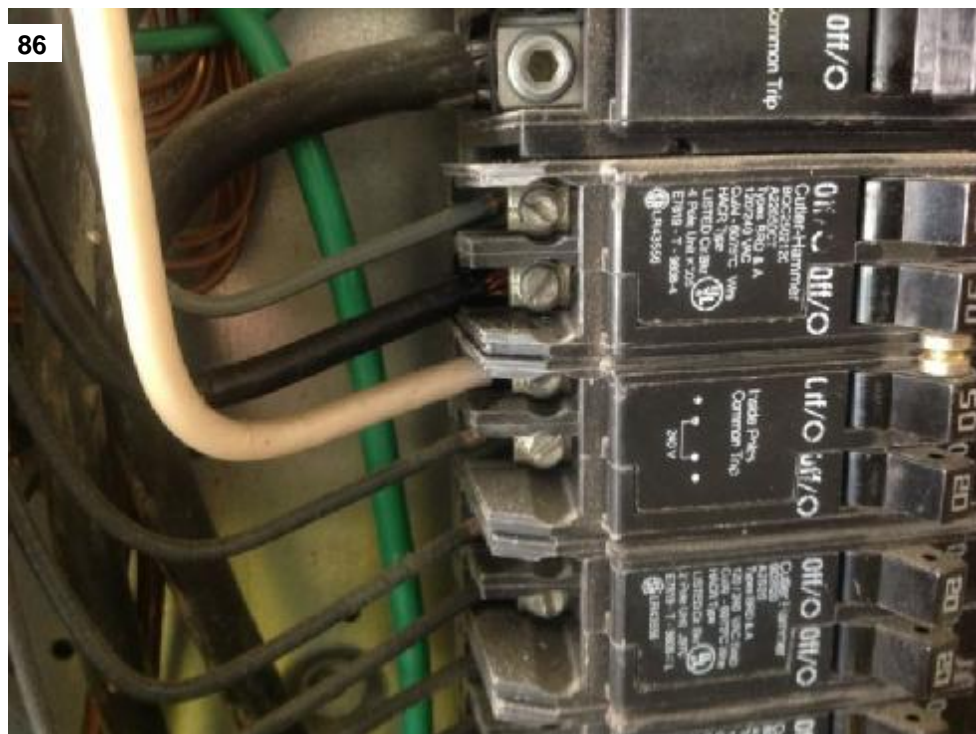
**D - Any white (neutral) wires used as hot wires should have black tape or coloring on them to indicate to service personnel that they are used as hot wires and not neutrals. Unidentified hot wires are a shock hazard.**

Neutral wire used as hot wire

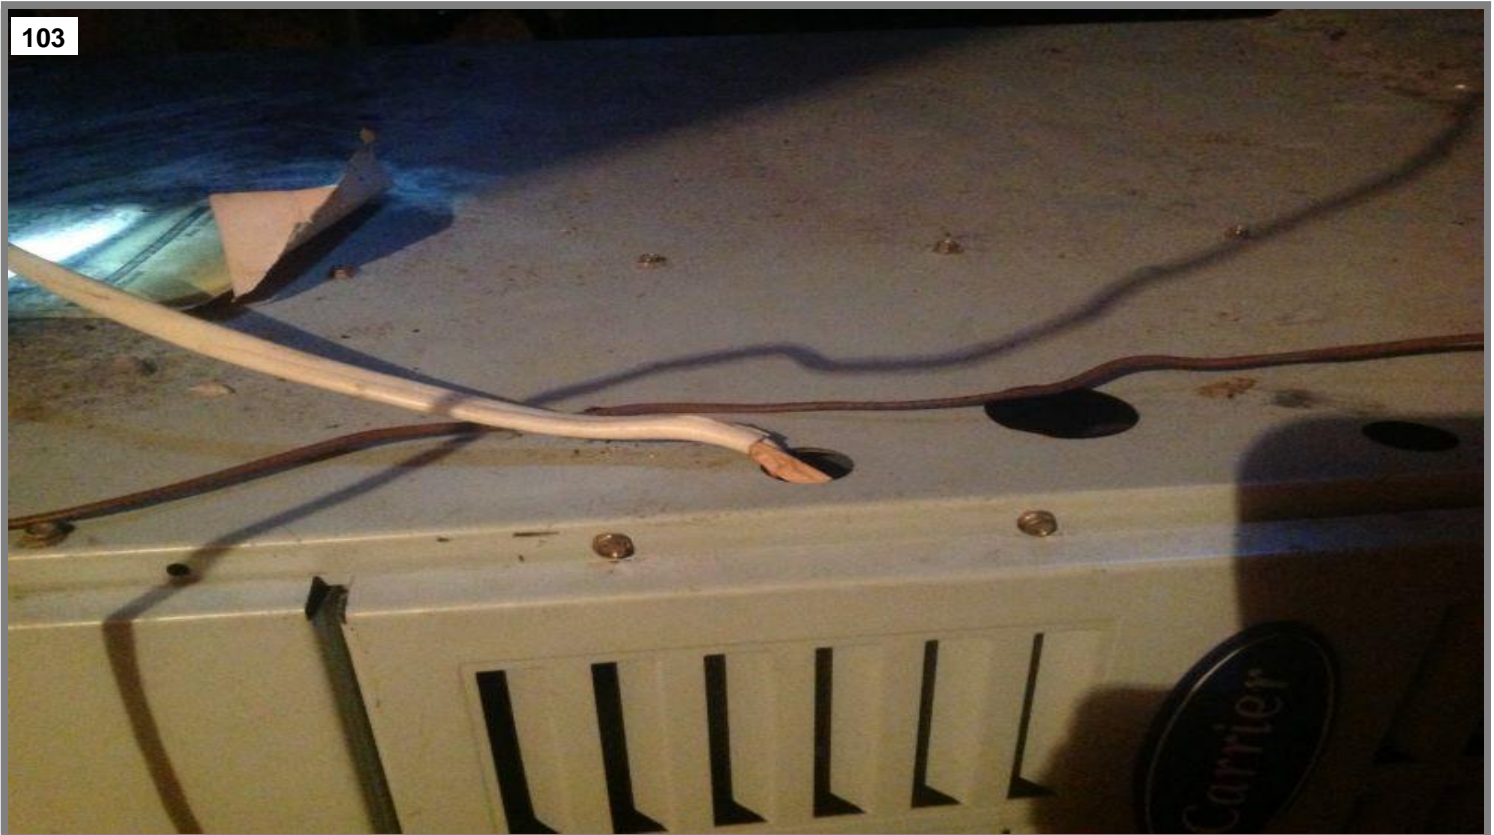
D - The electrical wiring to the furnace is improperly attached. The wire entering the furnace should be protected to prevent damage to the wire. A damaged wire may cause an electrical shock.

Unprotected wire going into furnace
