**101 Olive St
Willis, TX 77386**

PROPERTY INSPECTION REPORT

Prepared For:	Mr. Bill Sample Machner	
	(Name of Client)	
Concerning:	Bill Sample Machner 101 Olive St, Willis, TX, 77386	
	(Address or Other Identification of Inspected Property)	
By:	Dan smithTREC # 20iii716	10/31/2013
	(Name and License Number of Inspector)	(Date)
	(Name, License Number and Signature of Sponsoring Inspector, if required)

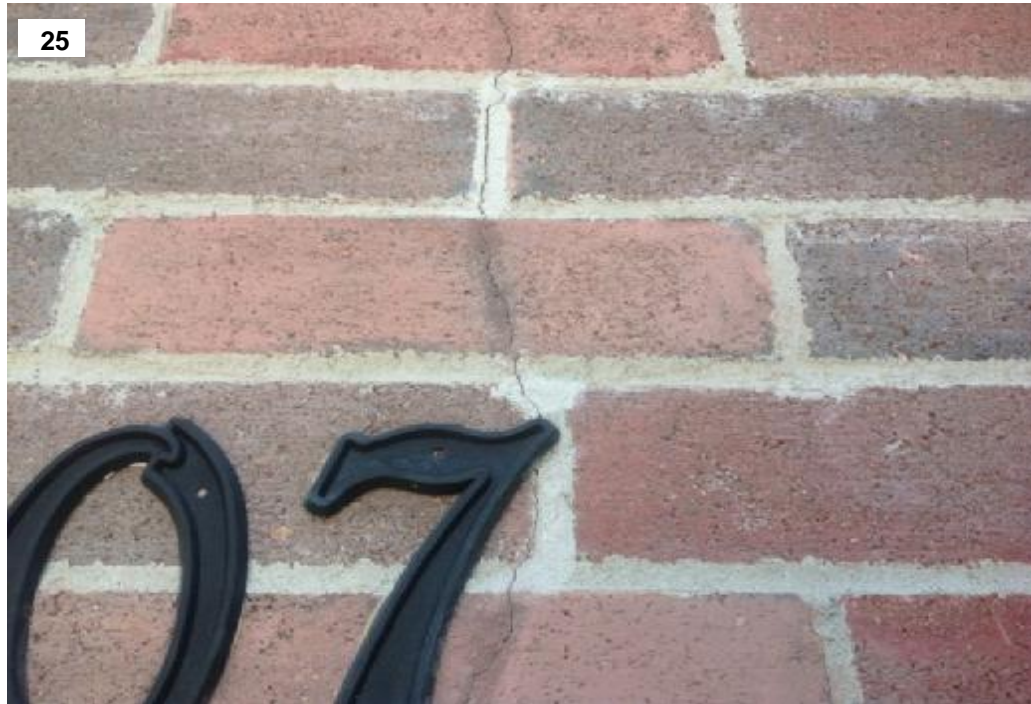
D - There were vertical cracks noted in the brick veneer. This type of crack is associated with lateral expansion and contraction due to extreme heat. Although this looks serious it does not indicate foundation movement. Recommend that a qualified contractor evaluate and repair as necessary.
D - Caulk and seal all gaps, cracks, and openings. There are various areas around the house that need sealing to prevent water and insect intrusion.

Crack in brick veneer located above garage

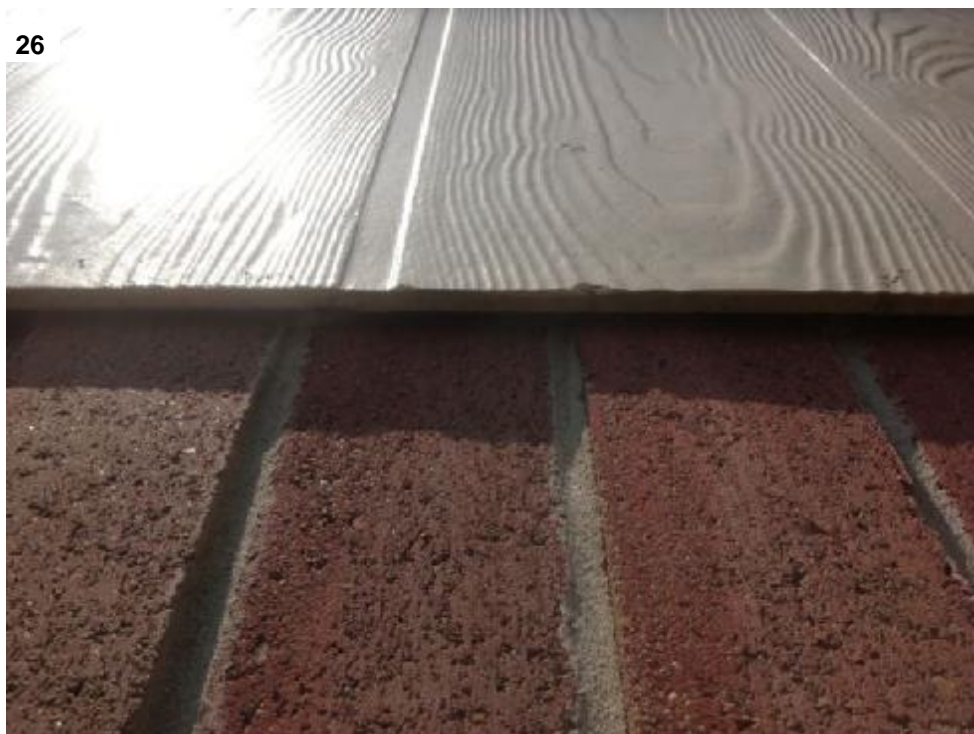
siding to brick needs caulking

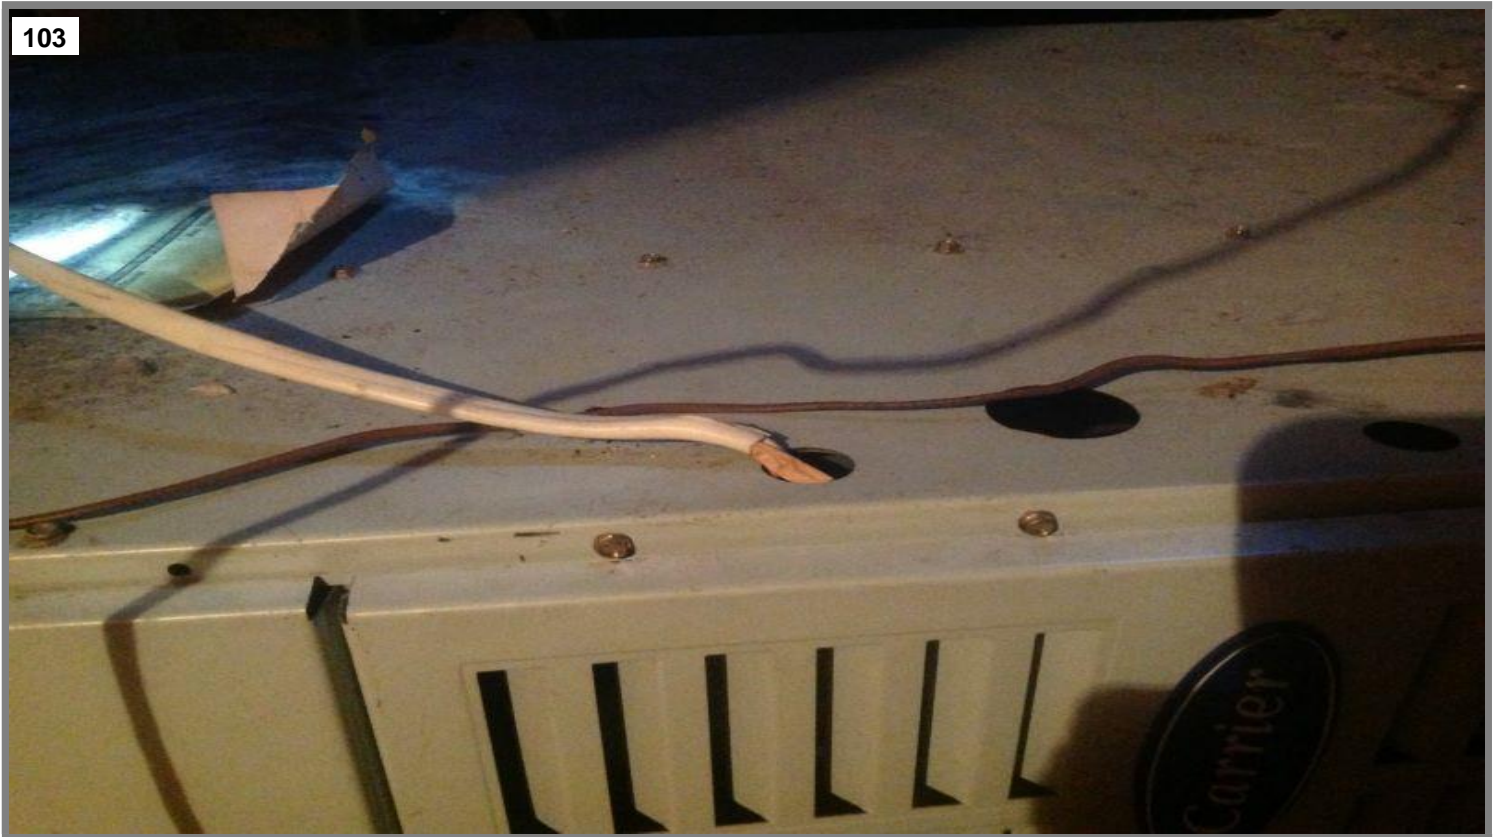
D - The electrical wiring to the furnace is improperly attached. The wire entering the furnace should be protected to prevent damage to the wire. A damaged wire may cause an electrical shock.

Unprotected wire going into furnace
