**101 Olive St
Willis, TX 77386**

PROPERTY INSPECTION REPORT

Concerning: Bill Sample Machner 101 Olive St, Willis, TX, 77386
(Address or Other Identification of Inspected Property)

By: Dan smithTREC # 20iii716 10/31/2013
(Name and License Number of Inspector) (Date)

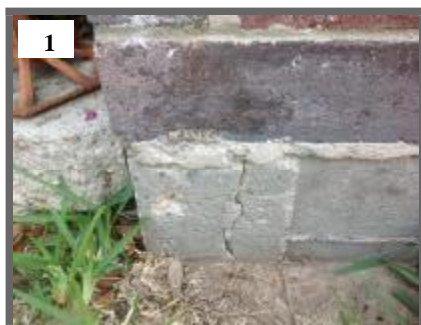
Corner pop
Crack

D - There are corner pops noted on the foundation. Corner pops are common on slab foundations and are not considered to be a major concern.

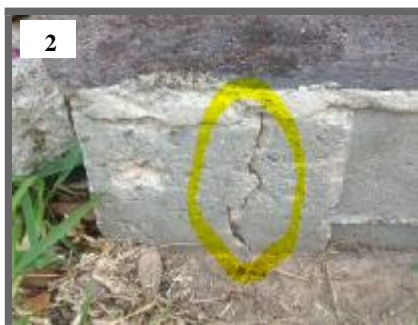
Corner pop
Crack

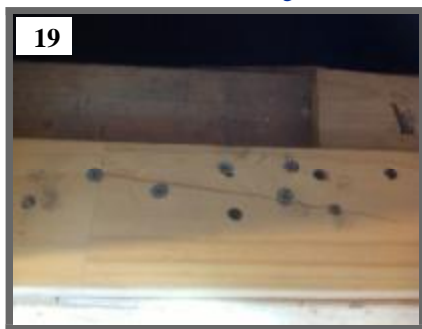
improper attachment of pull down stairs

D - The pull-down attic stairway was not properly attached to the rough framing with 16d nails or 1/4" x 3" lag screws per manufacturer's recommendations. (4 each side 3 each end) This will void the manufacturer's warranty. This is a safety hazard.
D - There is an inadequate platform in front of water heater, HVAC system. This makes inspection, maintenance, and repair difficult and hazardous. A minimum of 30 inch of service platform is required along the entire front side of unit(s).

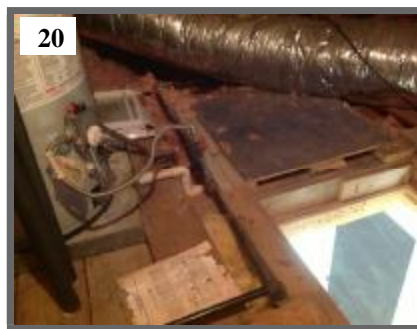
improper working platform in front of water heater

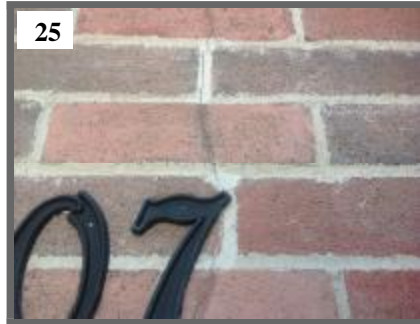
Crack in brick veneer located
above garage

D - There were vertical cracks noted in the brick veneer. This type of crack is associated with lateral expansion and contraction due to extreme heat. Although this looks serious it does not indicate foundation movement. Recommend that a qualified contractor evaluate and repair as necessary.

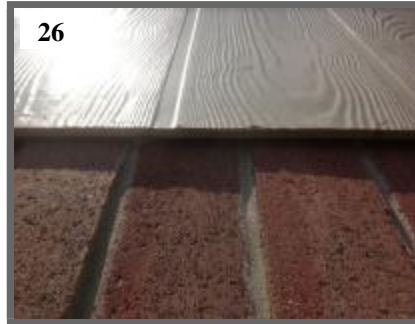
siding to brick needs caulking

D - Caulk and seal all gaps, cracks, and openings. There are various areas around the house that need sealing to prevent water and insect intrusion.

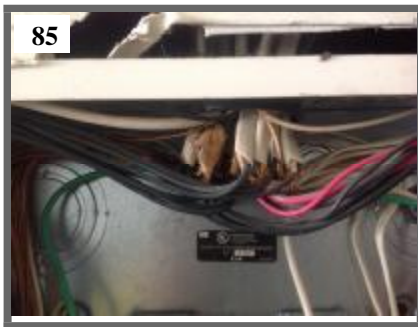
Conductor wires entering one knockout

D - Numerous branch circuit conductors are improperly entering the main electrical panel through a single large knockout located at the top of the panel box. Under current electrical standards, branch circuit conductors shall be evenly distributed and secured through the provided knockout holes. This does not comply with current fire regulations.

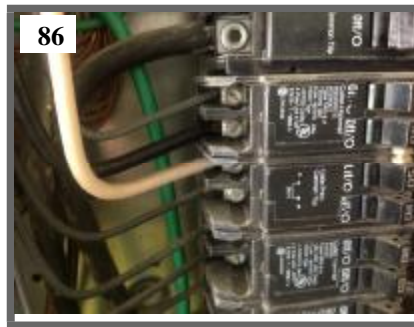
Neutral wire used as hot wire

D - Any white (neutral) wires used as hot wires should have black tape or coloring on them to indicate to service personnel that they are used as hot wires and not neutrals. Unidentified hot wires are a shock hazard.

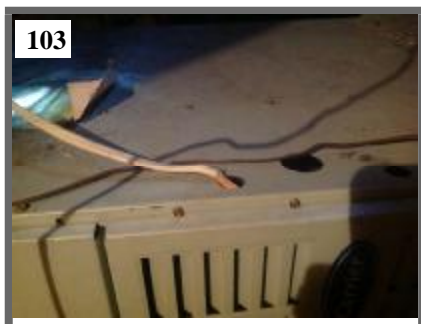
Unprotected wire going into furnace

D - The electrical wiring to the furnace is improperly attached. The wire entering the furnace should be protected to prevent damage to the wire. A damaged wire may cause an electrical shock.
