SampleReport

Subject Property

1222 Any Street Cedars St

Las Vegas, NV 89122

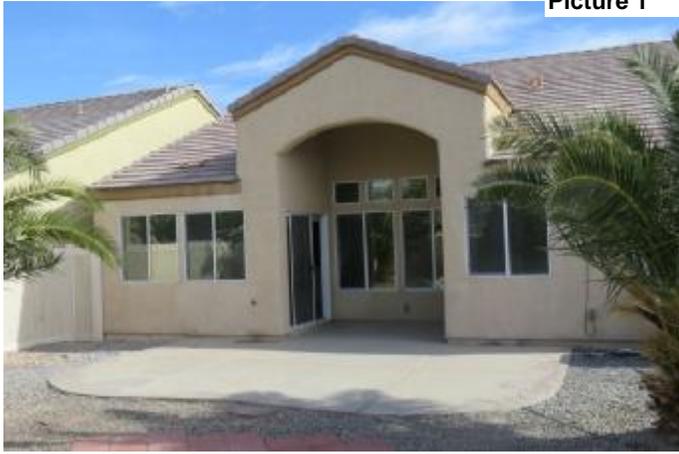
Picture 1

The patio and patio cover appeared to be in serviceable condition at the time of the inspection.

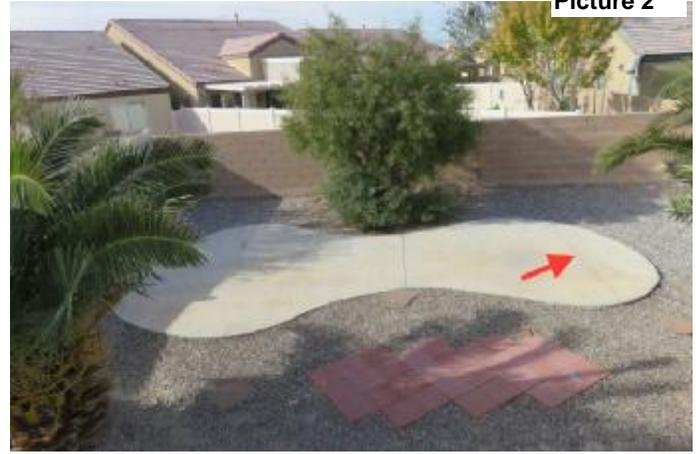
Picture 2

Common cracks up to 1/4" were noted in the island patio slab at the time of the inspection.

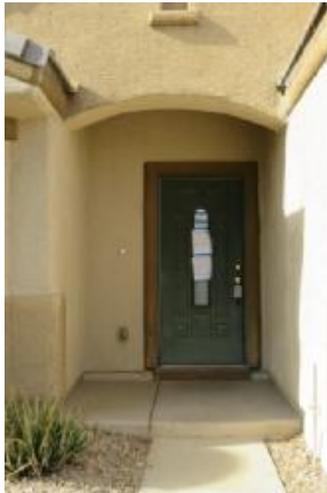
Picture 3

The front porch appeared to be in serviceable condition at the time of the inspection.

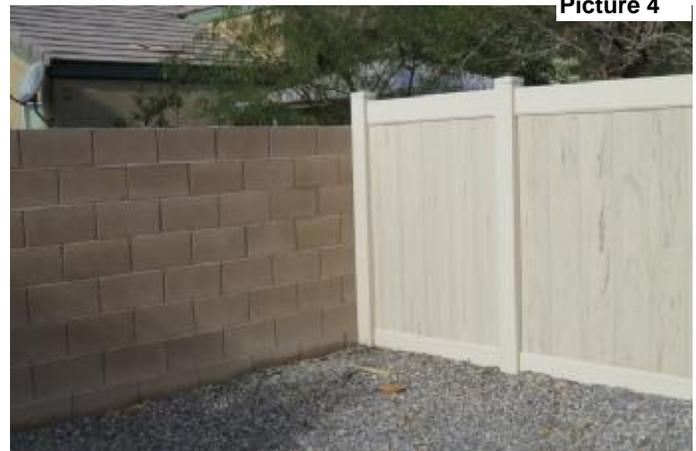
Picture 4

The block wall, plastic fencing and gates appeared to be in serviceable condition at the time of the inspection.

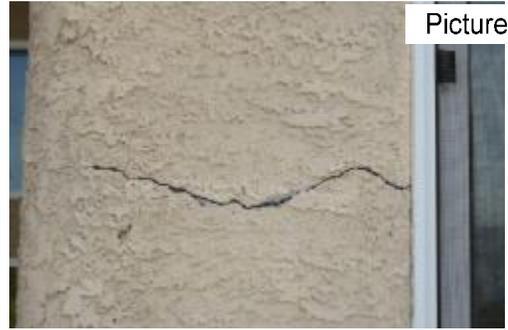
Picture 8

Common cracks up to 1/8" were found in the exterior walls at the time of the inspection.

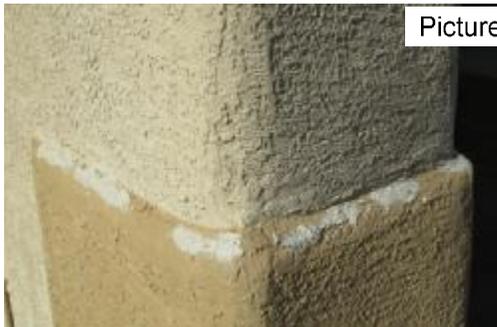
Picture 11

Signs of prior repairs noted on the exterior stucco trim.

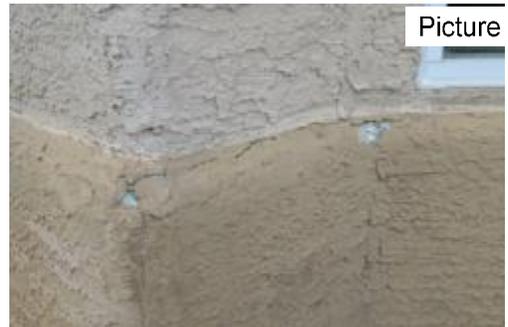
Picture 12

Cracks up to 1/8" were found in the exterior stucco trim

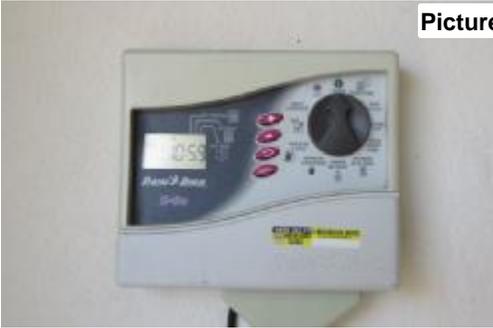
Picture 13

The sprinkler timer appeared to be operational at the time of the inspection.

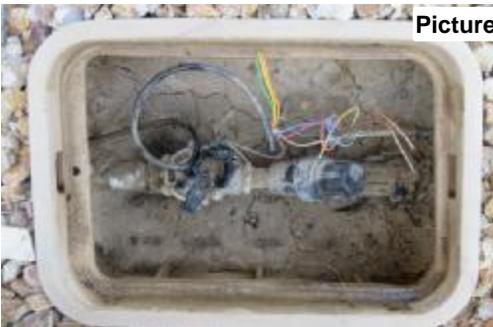
Picture 15

The sprinkler front control valve appeared to be operational at the time of the inspection.

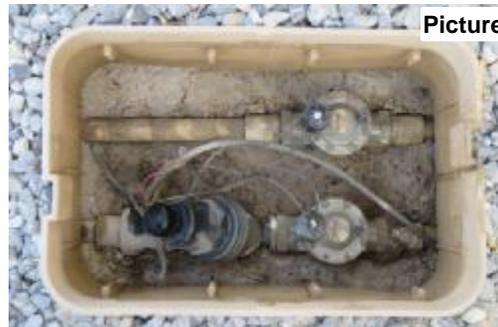
Picture 16

The sprinkler back control valve appeared to be operational at the time of the inspection.

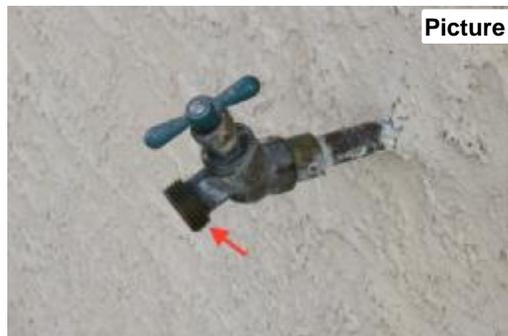
Picture 17

The back yard hose faucet is not a anti-siphon type valve. Recommend installing a anti siphon adapter. (*)

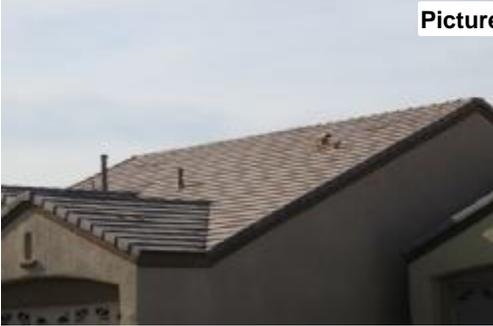
Picture 19

The main roof covering appears to be in serviceable condition.

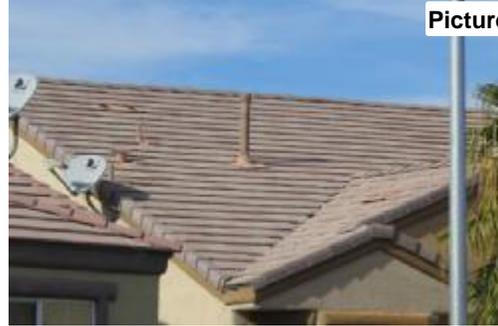
Picture 20

The main roof covering appears to be in serviceable condition.

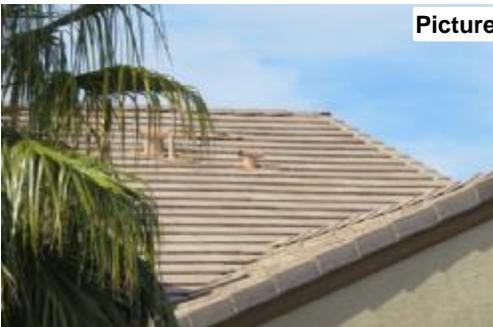
Picture 21

The main roof covering appears to be in serviceable condition.

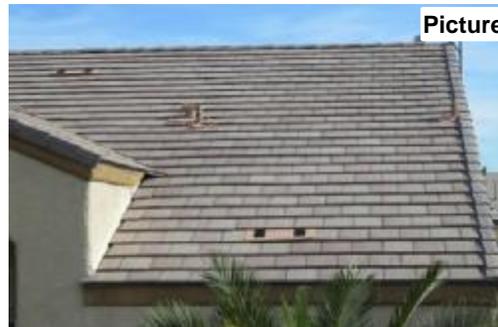
Picture 22

The main roof covering appears to be in serviceable condition.

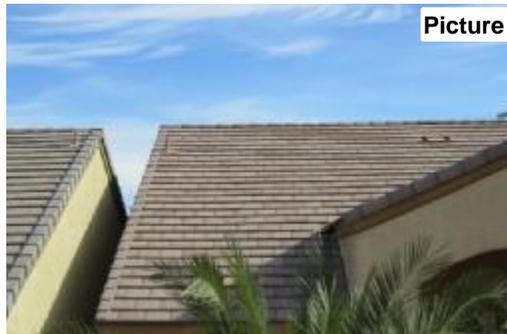
Picture 23

The main roof covering appears to be in serviceable condition.

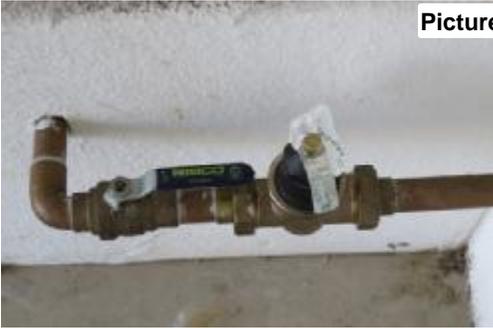
Picture 25

Main water shut off valve and regulator is installed in the garage.

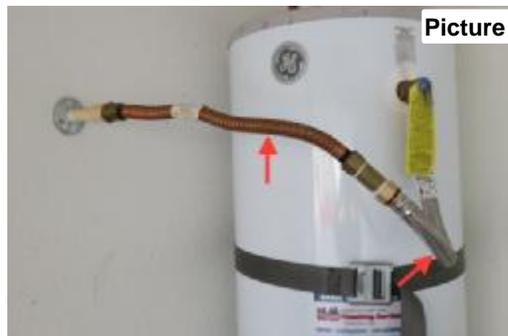
Picture 29

The temperature pressure line is not correct the line is considered to be trapped. (2,4)

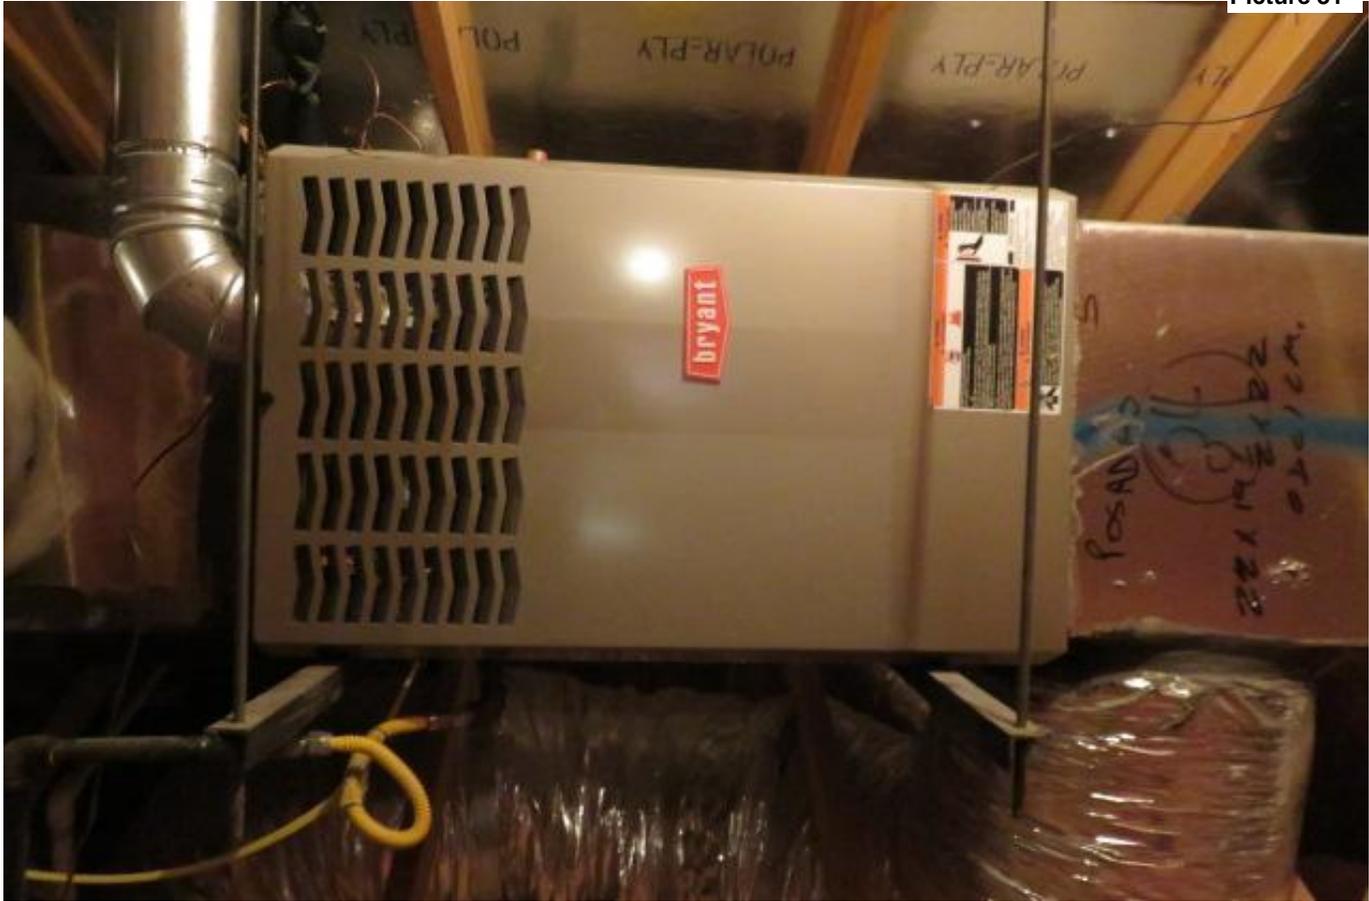
Picture 31

The heating system appeared to be operational at time of inspection.

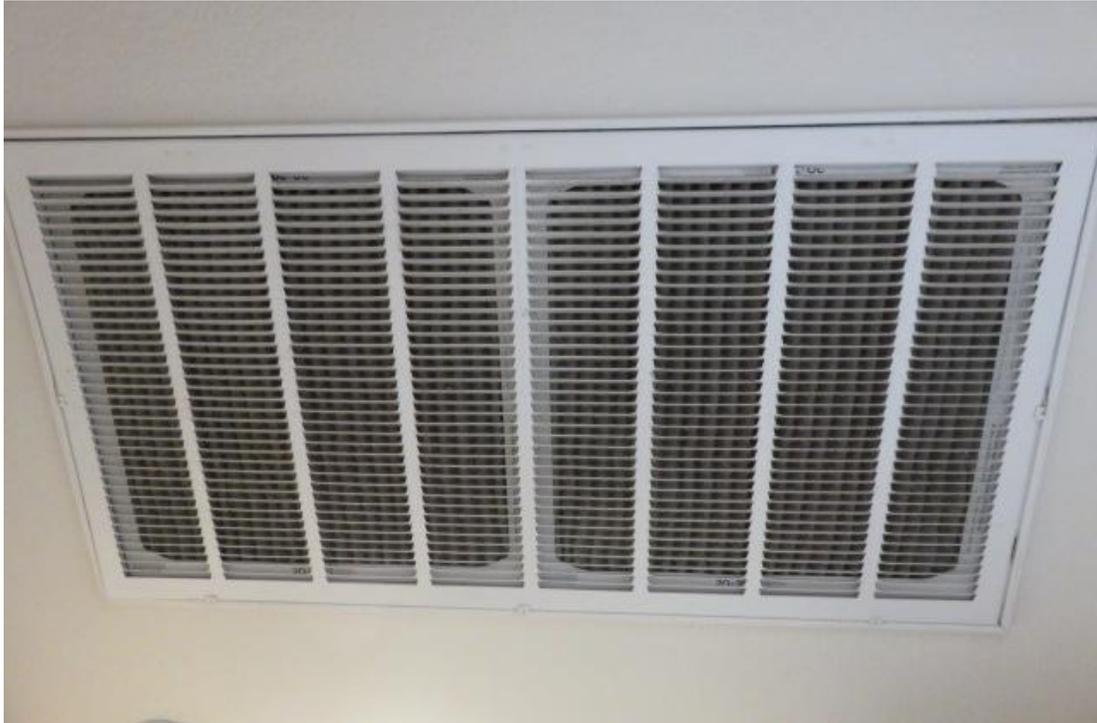
Picture 37

Suggest changing the air filters at the time of the inspection. (20x20x1) 2 each

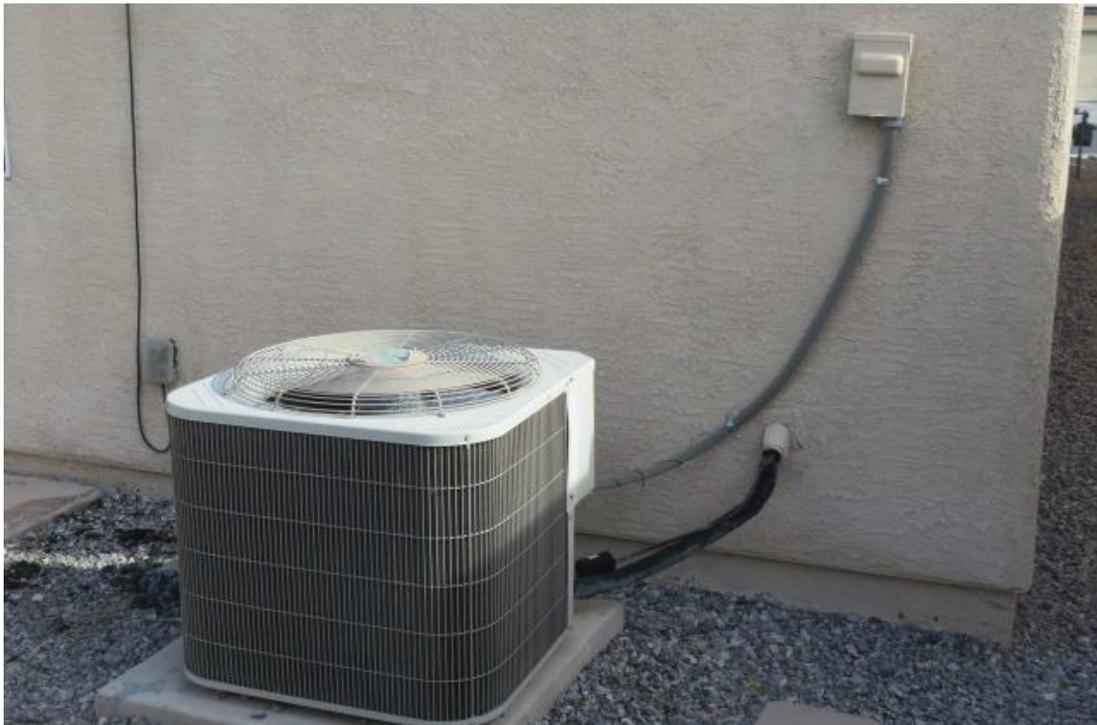
Picture 38

The outside air temperature was below 65 degrees at the time of the inspection. I was unable to operate the system. Operating the system at this temperature could damage the system. Recommend servicing the cooling system and checking the refrigerant level prior to next cooling season.

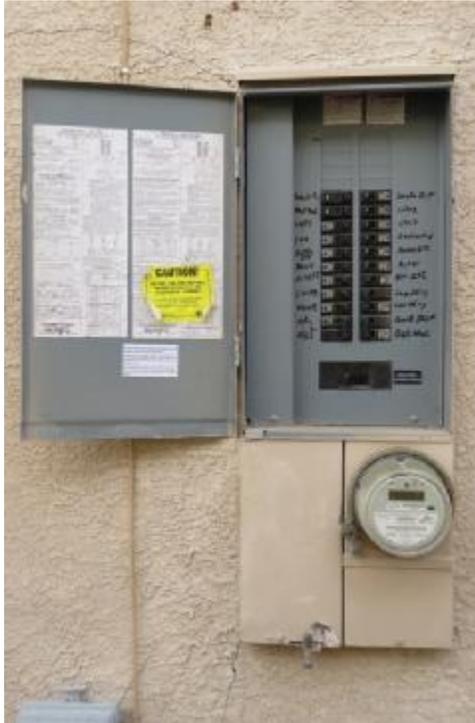
Picture 43

The main panel appeared to be in serviceable condition at the time of the inspection.

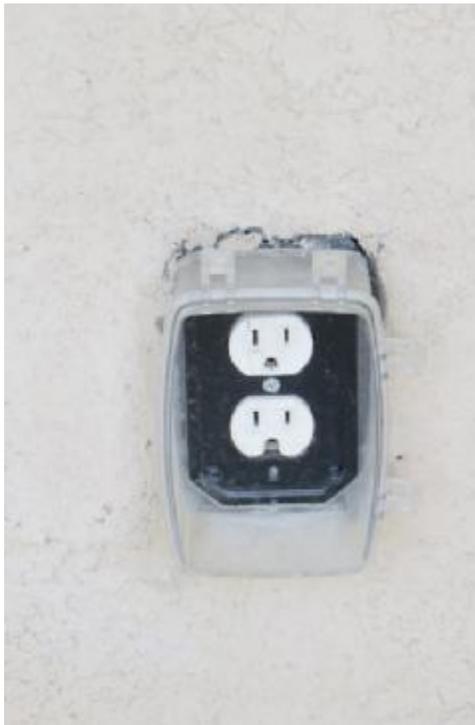
Picture 44

The patio outlet cover is damaged or missing. (*)

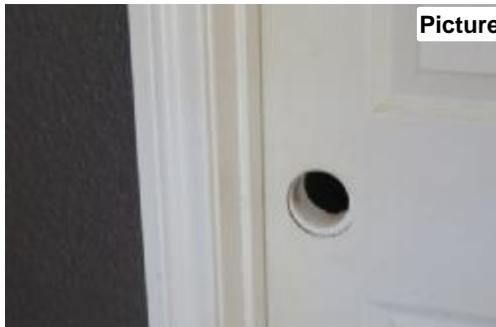
Picture 51

The laundry room door handle is missing.

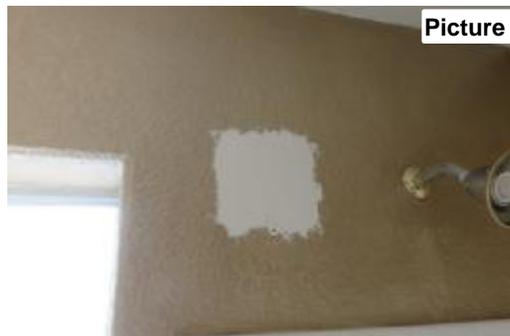
Picture 53

Signs of prior repairs noted above the main bathroom tub enclosure

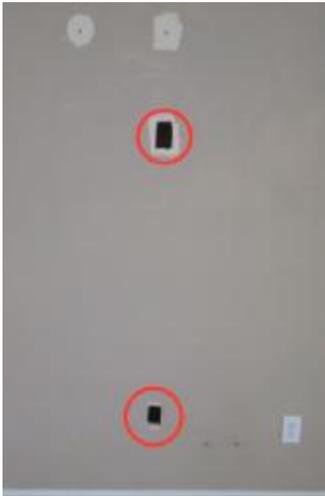
Picture 55

Two 2"x4" holes found in the family room walls.

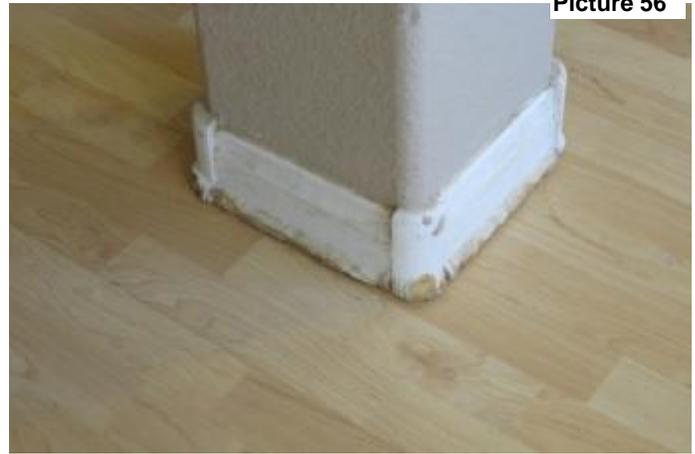
Picture 56

Base board is damaged around the post in-between the dining and family room.

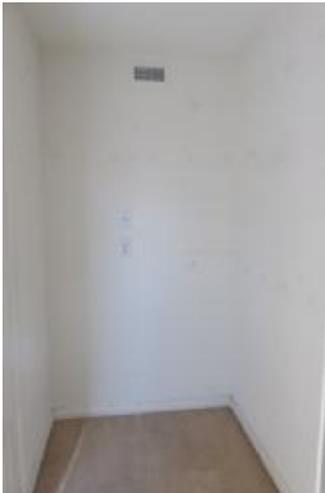
Picture 57

All of the bedroom closet cloths hangers are missing.

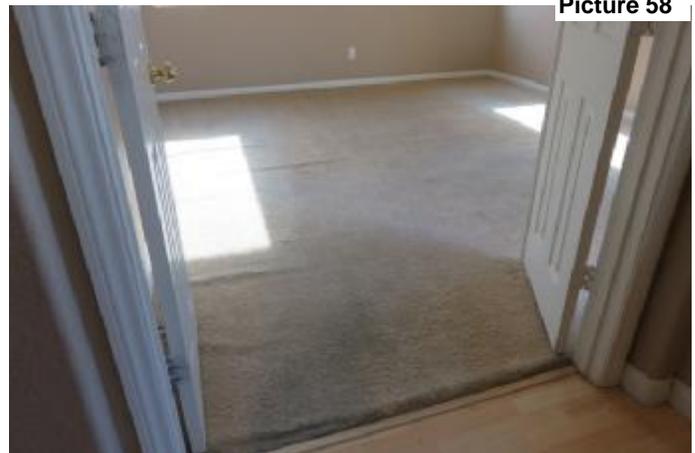
Picture 58

Carpet show signs of wear.

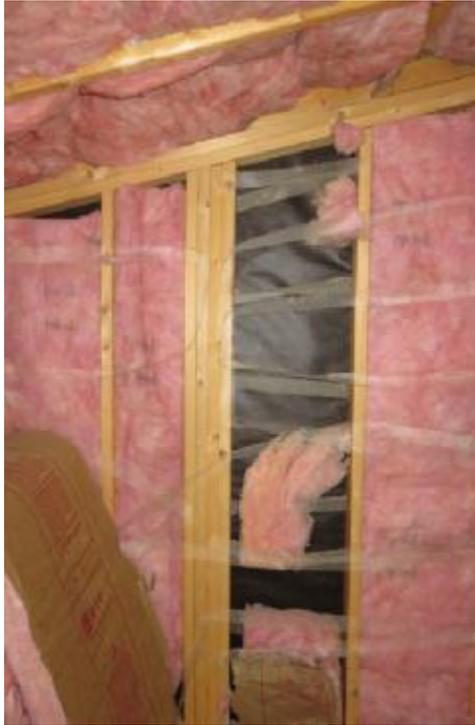
Picture 61

Some of the insulation has been removed from the wall of the attic storage area. Recommend putting the insulation back in place.

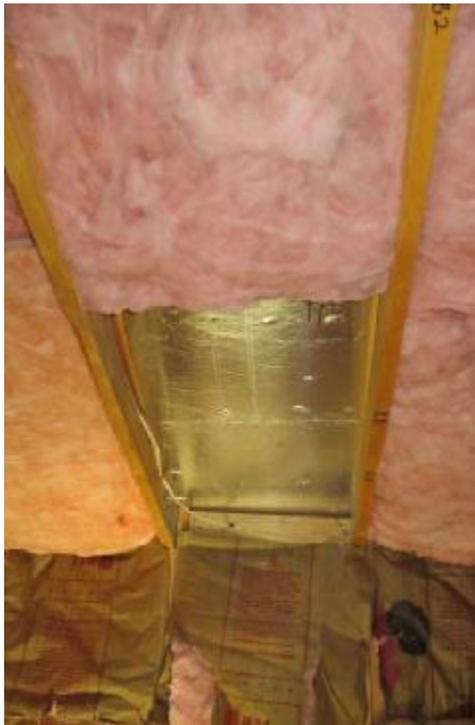
Picture 62

Some of the insulation has been removed from the ceiling of the attic storage area. Recommend putting the insulation back in place.

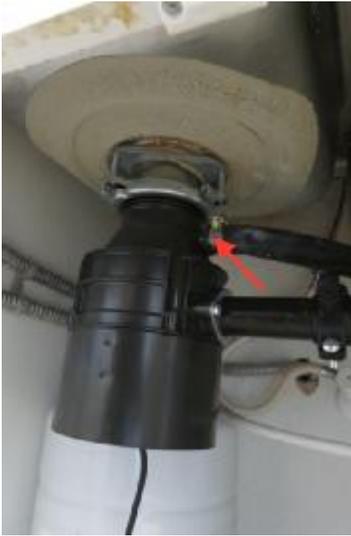
Picture 67

The dishwasher appears to operate but the knock out-plug does not appear to have been removed from the disposal. When the dishwasher drains water comes out of the air gap device. (2)

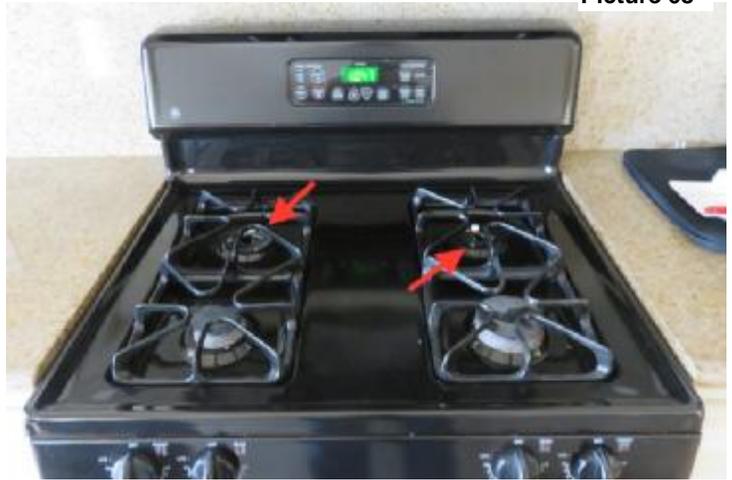
Picture 68

2 of the burner are missing from the range. (*)

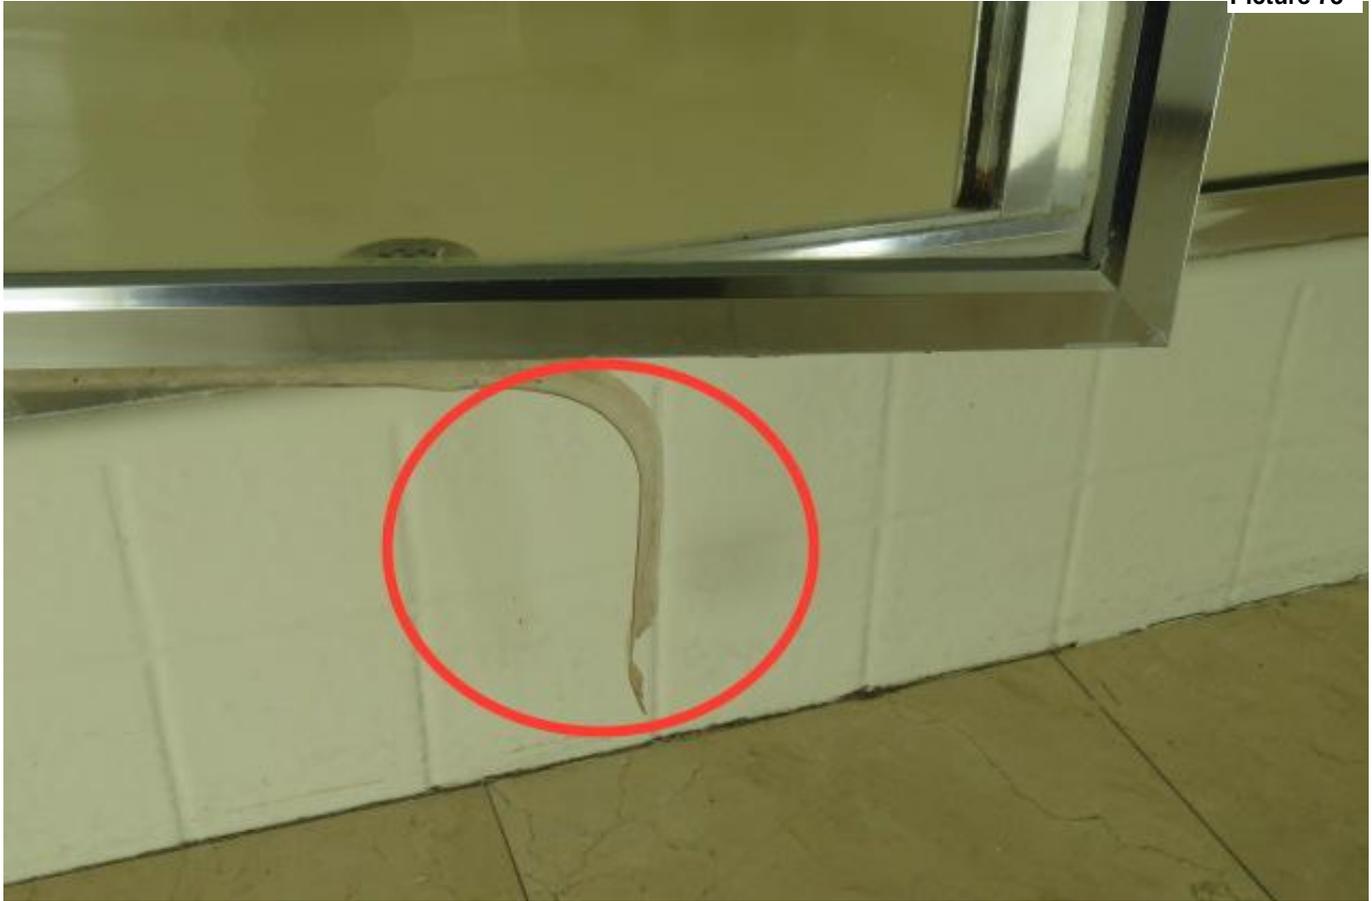
Picture 73

The master bathroom shower door seal is damaged.
