Report # / I.D : Sample Report
Inspection Date : February 01 2026 **Time :** 10:00 am
Client Name : Amber Sample
Property Address : 120 Any St SW Palm Bay, FL 32908

INSPECTION CONDITIONS / GENERAL PROPERTY INFORMATION

Type Of Inspection: Pre-Purchase Inspection

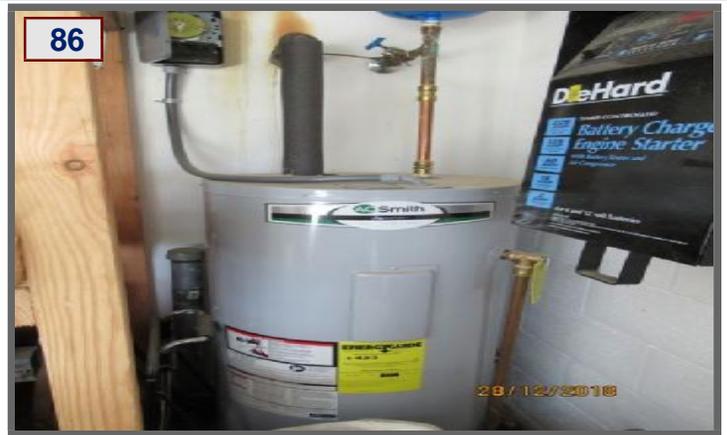
Ruud 80 gallon electric water heater located in first floor closet manufactured in 2001 typical lifespan is 10 years, all water heaters were wrapped in insulation and not fully visible at the time of
