HOME INSPECTORS

Report # / I.D : lou072622
Inspection Date : July 26 2027 **Time :** 10:00 am
Client Name : Louie Wilson
Property Address : 553 Wish Ave Granada Hills , Ca 91344

Type Of Inspection: Pre-Purchase Inspection

Home Type / Style: Single Family Home

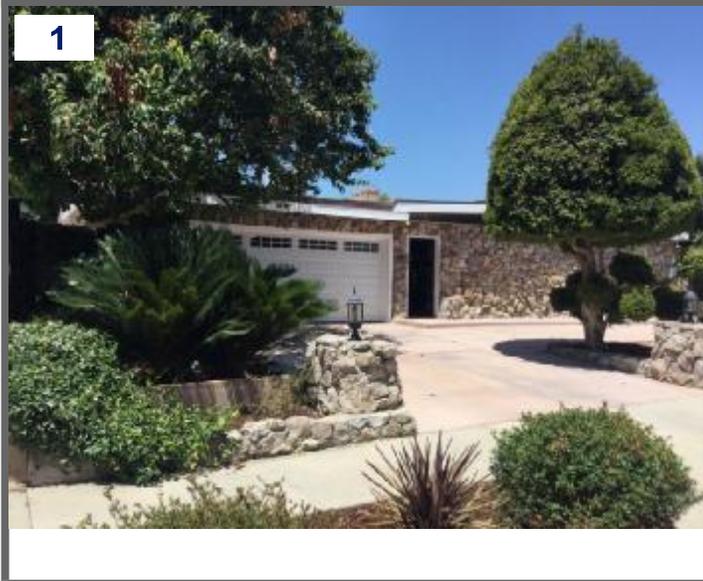
House foundation is not visible, because patio slab, earth and sidewalk blocks view, view is Limited or blocked. (1) (2) Recommended evaluation by a licensed structural engineer / Geotechnical engineer

House foundation is not visible, because patio slab, earth and sidewalk blocks view, view is Limited or blocked. (1) (2)

Recommend evaluation or repairs by a Qualified licensed contractor / specialty trades person.

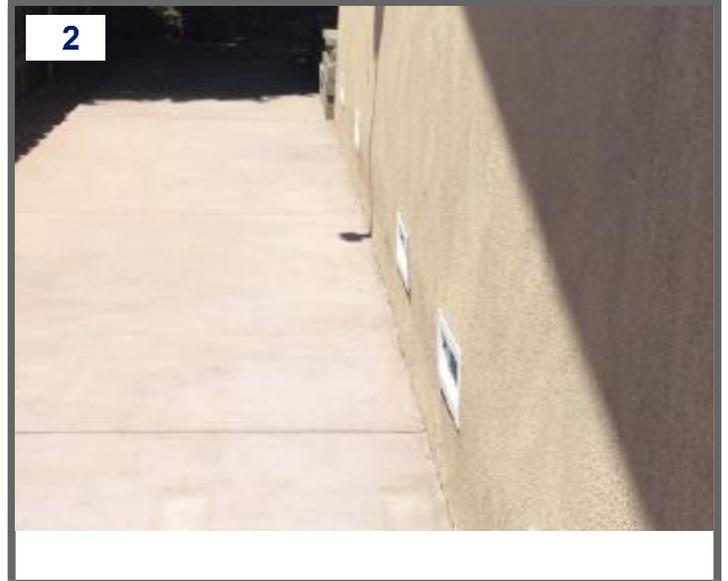
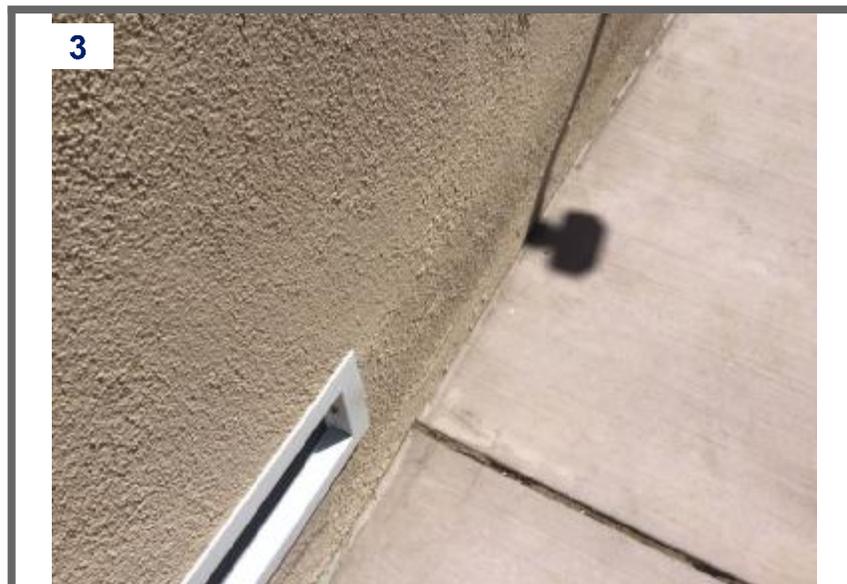
See Photo # 2,3 Stucco finish goes past the wood framed wall and than covers the concrete footing, this is the area where cracks, gaps, or blistering can / may or will appear horizontally /diagonal at various areas on the stucco wall. Normal construction for the age of this house.

See Photo # 2,3 Stucco finish goes past the wood framed wall and than covers the concrete footing, this is the area where cracks, gaps, or blistering can / may or will appear horizontally /diagonal at various areas on the stucco wall. Normal construction for the age of this house. Monitor and repair cracks if seen. (2) (5)

this is the area where cracks, gaps, or blistering can / may or will appear horizontally /diagonal at various areas on the stucco wall. Normal construction for the age of this house. Monitor and repair cracks if seen. (2) (5)

Monitor and repair cracks if seen. (2) (5)

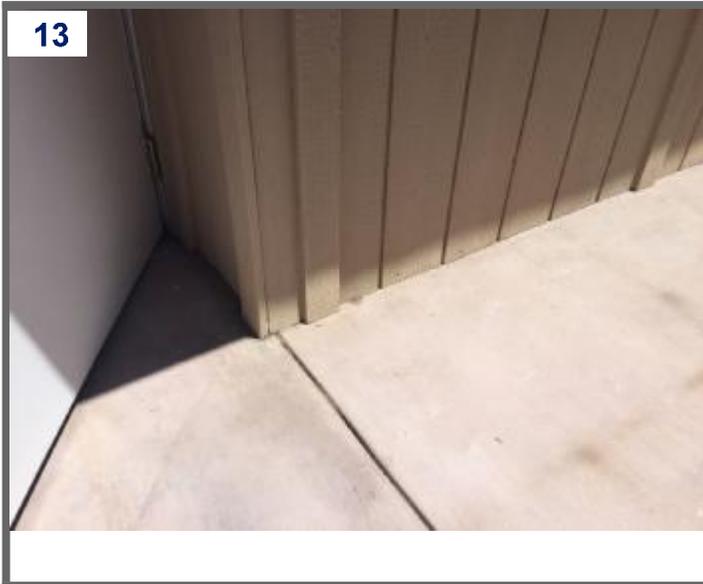
See Photo # 13

Back of garage wood siding is on grade, should be 1 in from grade, missing metal flashing. (2)

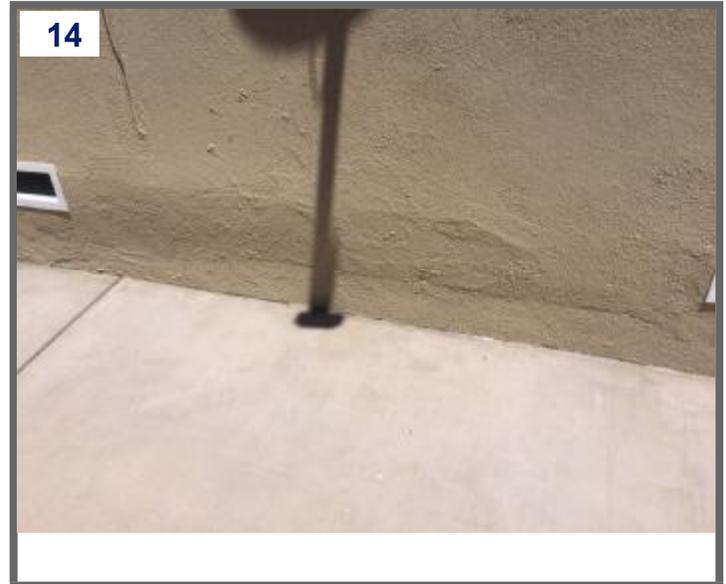
See Photo # 14

Stucco is bulging. (2)

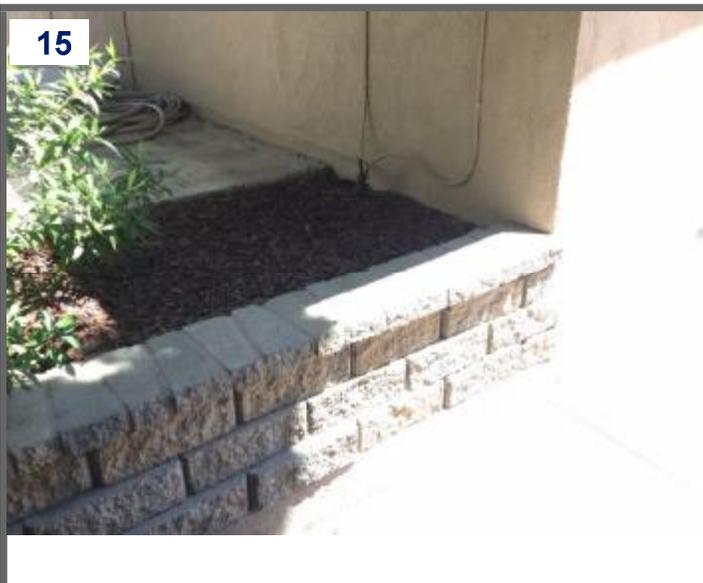
See Photo # 15

Back Bedroom wall, garden planter is above foundation grade, possibly moisture insulation. (2)

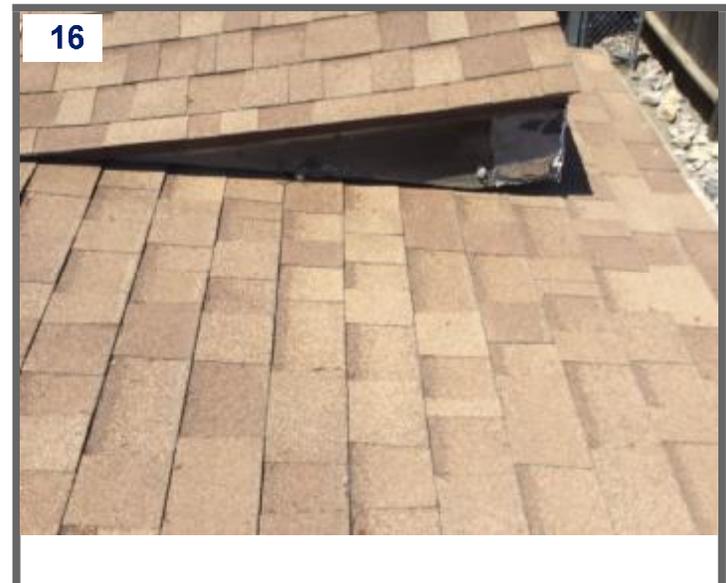
See Photo # 16

Some areas of fascia board needs repairs. (2)

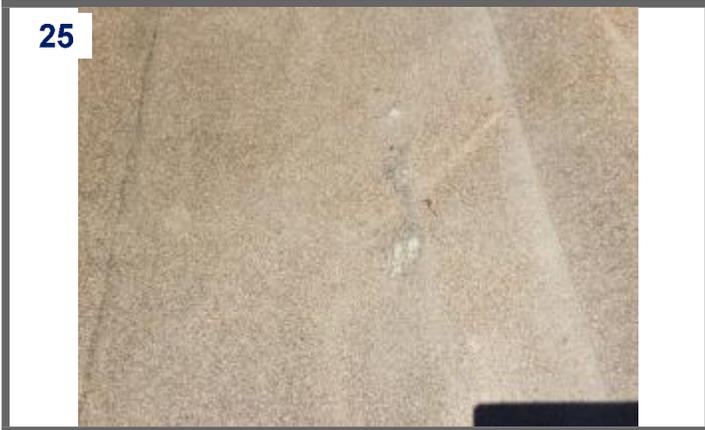
Flat roofing areas has a damaged area. (2)

See Photo # 25
Flat roofing areas has a damaged area. (2)

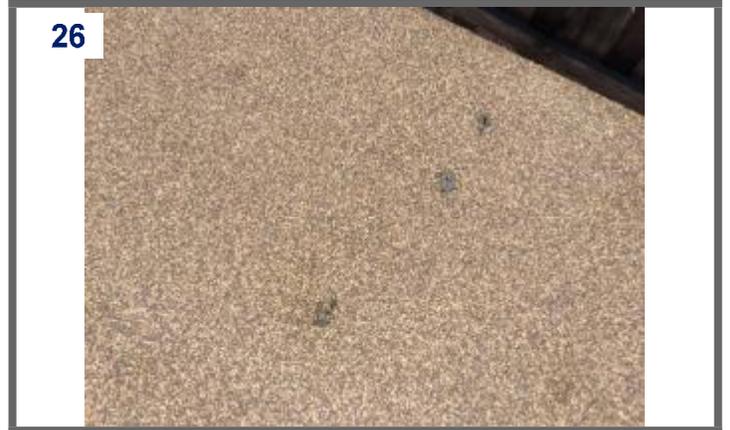
See Photo # 26
Flat roofing at some areas nail pop up's. (2)

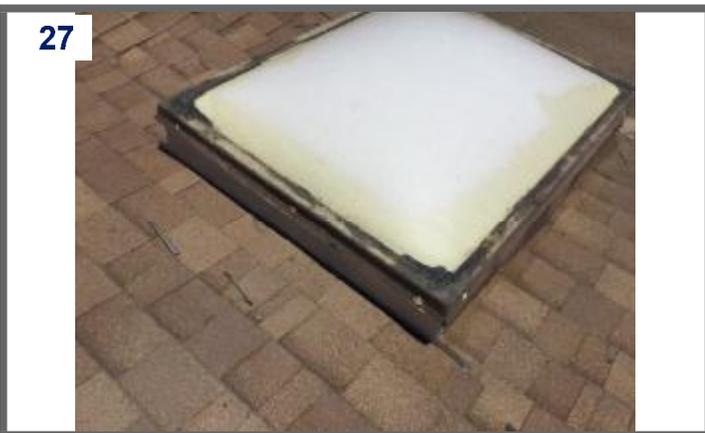
Skylight seal is loose, plexiglass has cracks at edges. (2)

See Photo # 27
Skylight seal is loose, plexiglass has cracks at edges. (2)

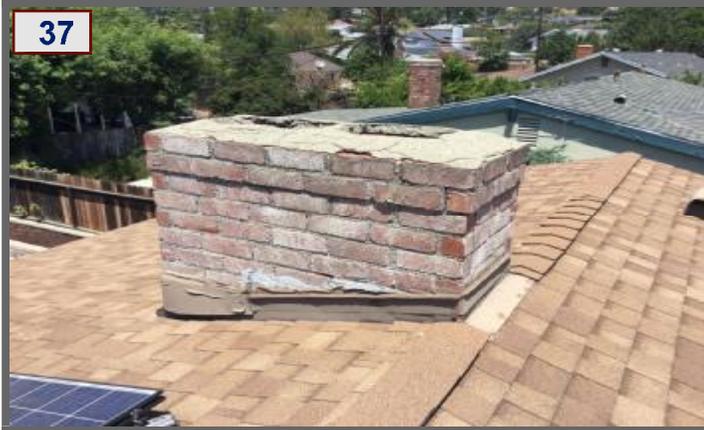
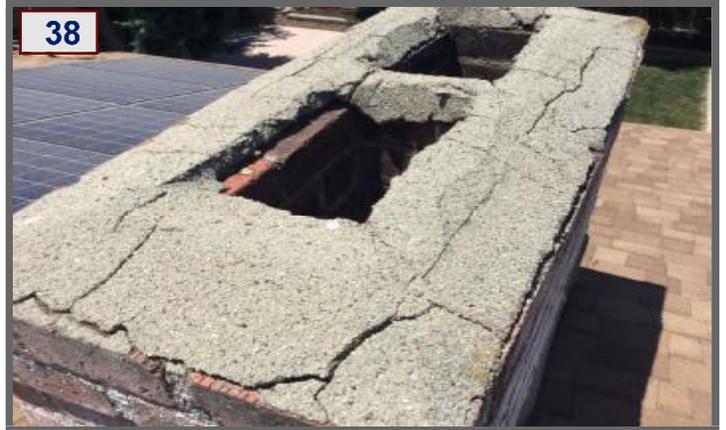
Chimney crown has cracks. (2)

Chimney: Older, unlined chimney. Recommend evaluation by a qualified specialist. (2)

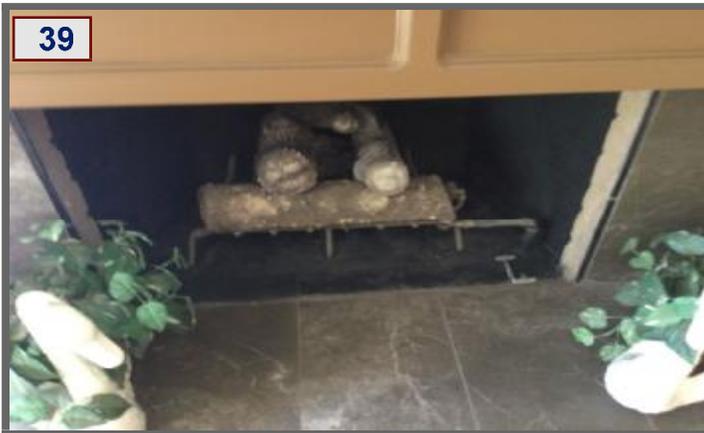
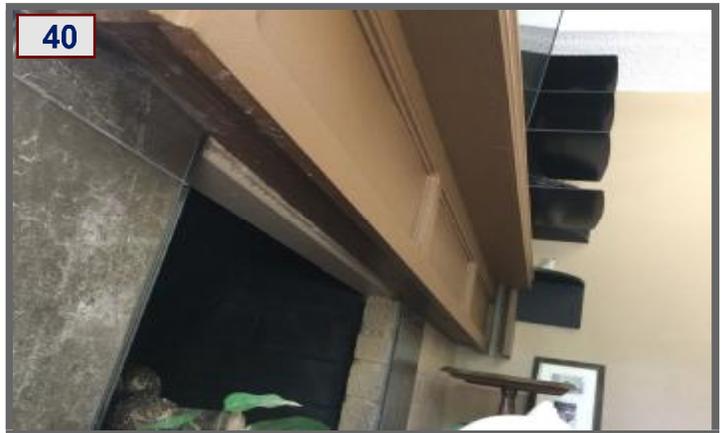
Wood mantle is too close to opening, possible safety hazard. (2)

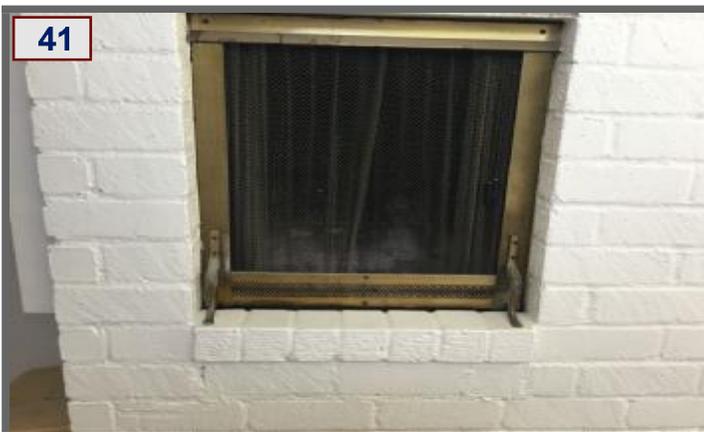
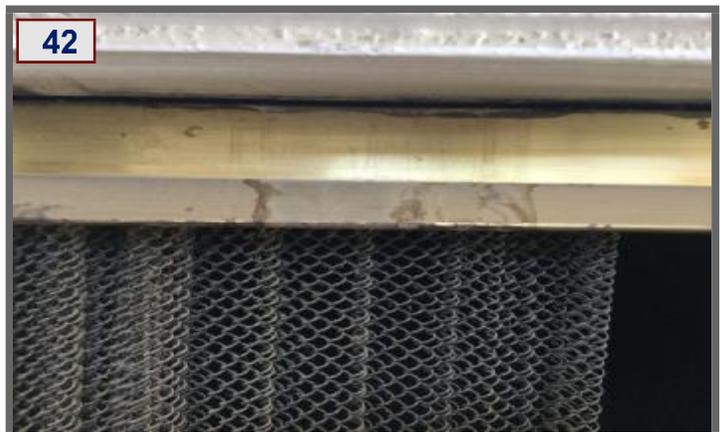
Kitchen fireplace no gas. (2)

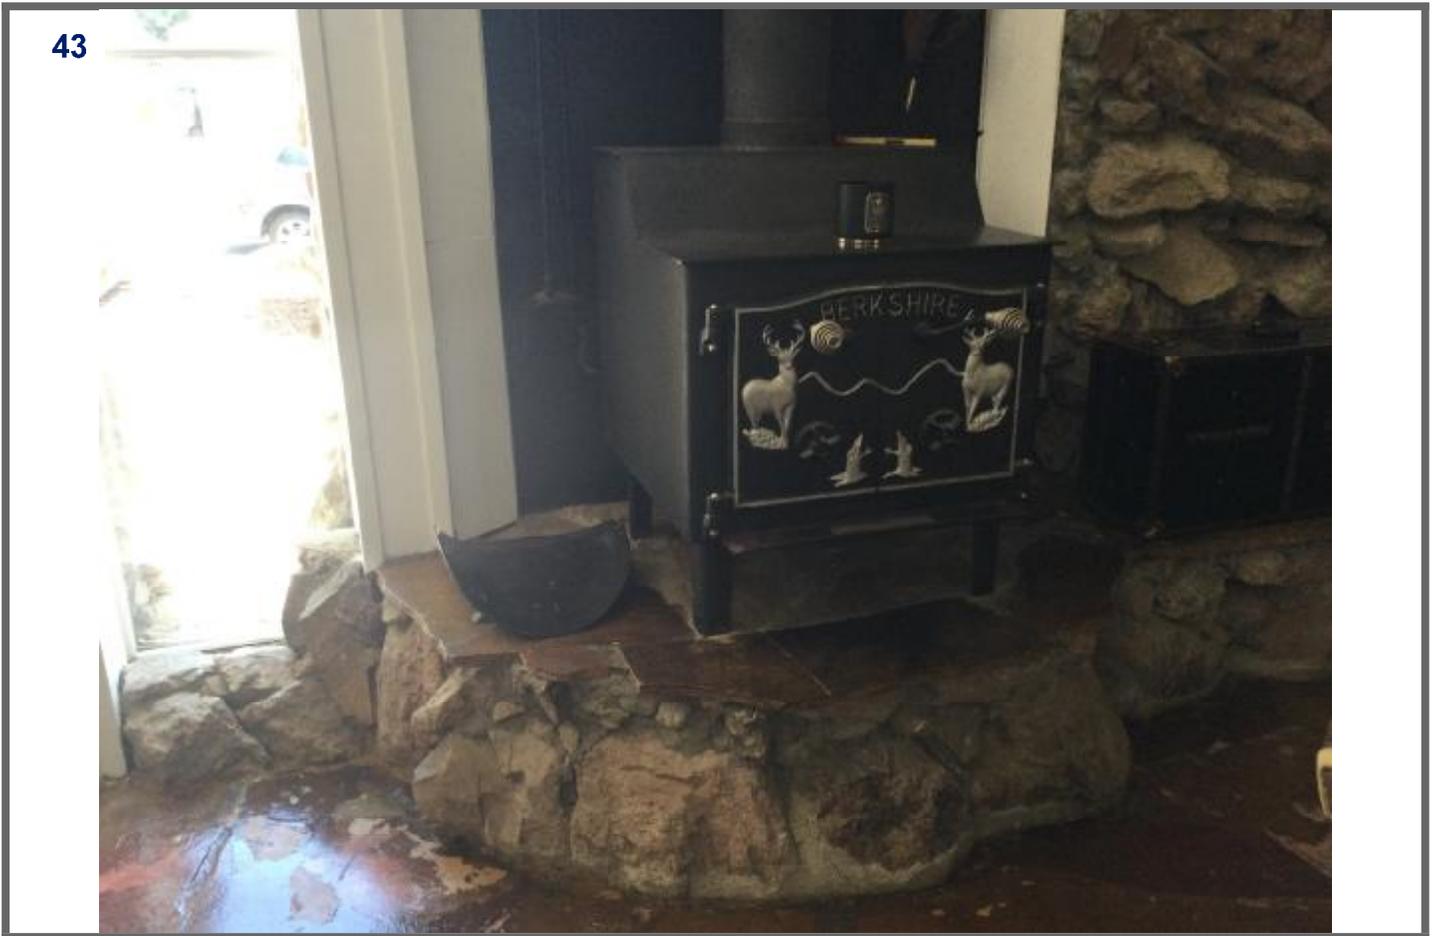
See Photo # 43

Wood burning wood stove, ask sellers for operational instructions. (2)

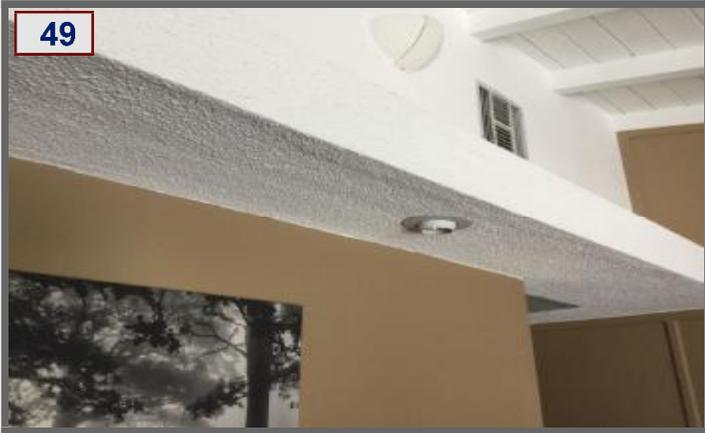
49

Soffit ceiling may contain a percentage of asbestos. (2)
Entryway

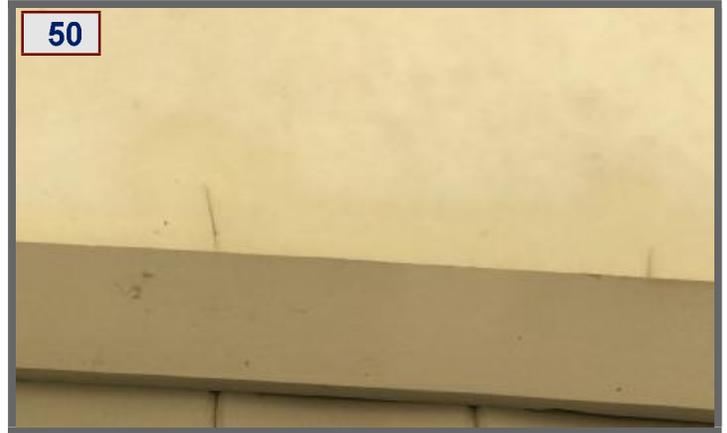
See Photo # 50 Atrium skylight has cracks. (2)

Atrium skylight has cracks

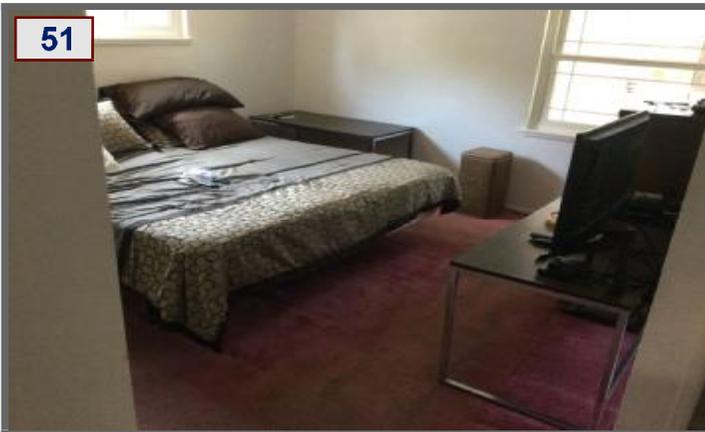
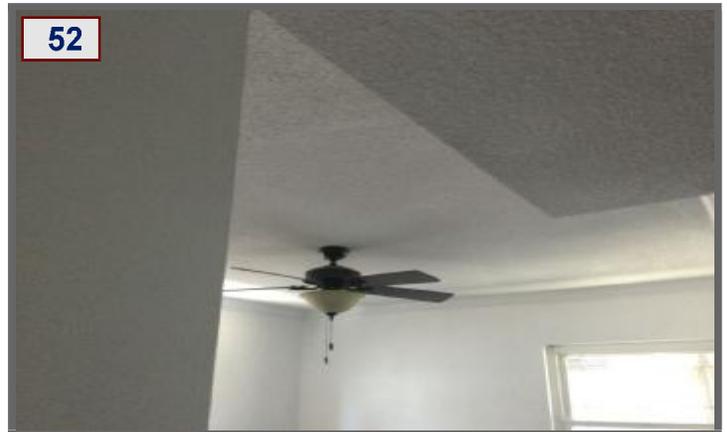
See Photo # 51,52 Ceiling has repairs, ask sellers reasons for repairs, Note ceilings with acoustic type covering or cottage cheese, may contain a percentage of asbestos. (2) (4)

Ceiling has repairs, ask sellers reasons for repairs, Note ceilings with acoustic type covering or cottage cheese, may contain a percentage of asbestos. (2) (4)

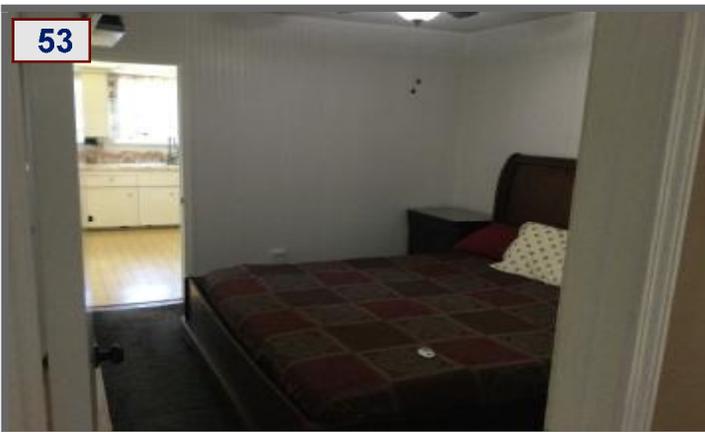
53

This 2nd bedroom did not have fire egress. (2)

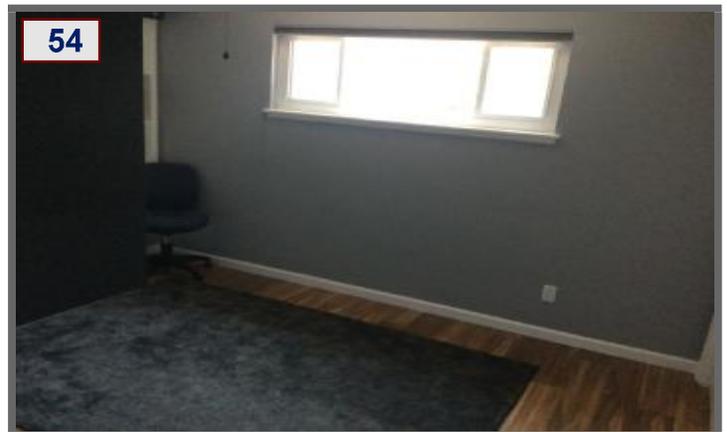
See Photo # 54 Window too small for fire egress, safety hazard. (2) Note ceilings with acoustic type covering or cottage cheese, may contain a percentage of asbestos. (2) (4)

Window too small for fire egress, safety hazard. (2)
Note ceilings with acoustic type covering or cottage cheese, may contain a percentage of asbestos. (2) (4)

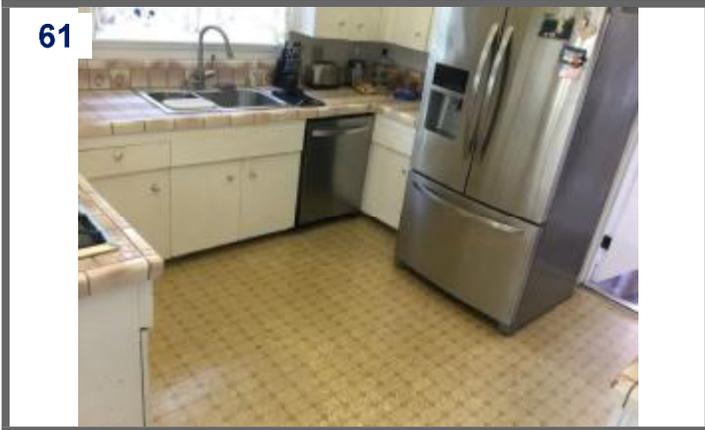
61

Kitchen lights, some have weak ballast, needs repairs. (2)

Kitchen lights, some have weak ballast, needs repairs. (2)
Kitchen, Recommend upgrading electric outlets to Ground Fault Circuit Interrupt type (GFCI), for safety of occupants. (2)

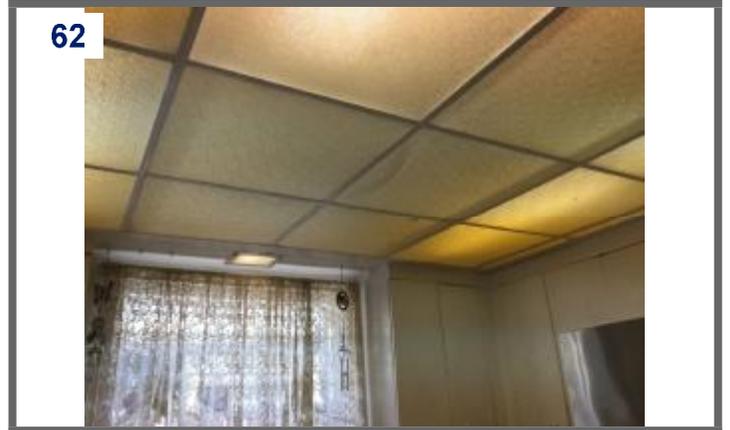
62

Kitchen, Recommend upgrading electric outlets to Ground Fault Circuit Interrupt type (GFCI), for safety of occupants. (2)

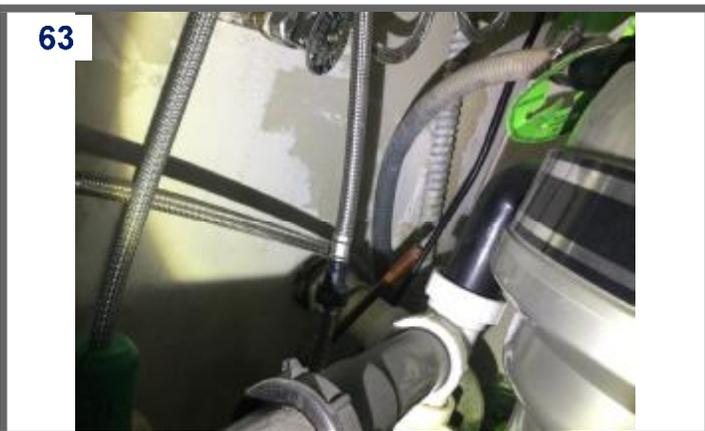
63

Dishwasher: Air gap missing, building and safety requires air gap, to segregate waste water bacteria migrating from waste disposer hose back into the dishwasher pump. (2)

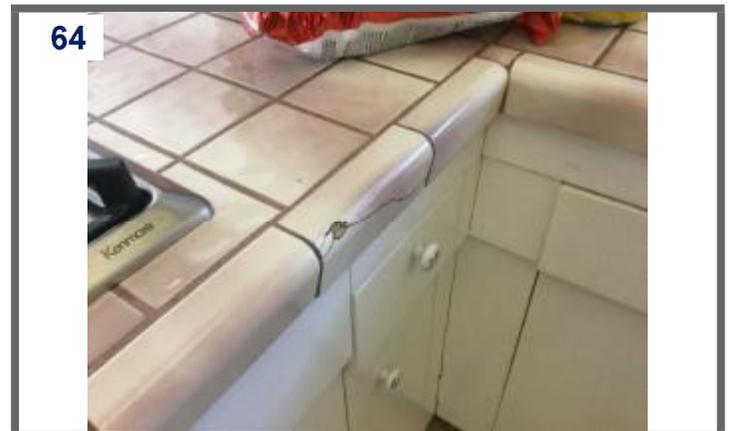
64

Some counter top tile are cracked. (2)

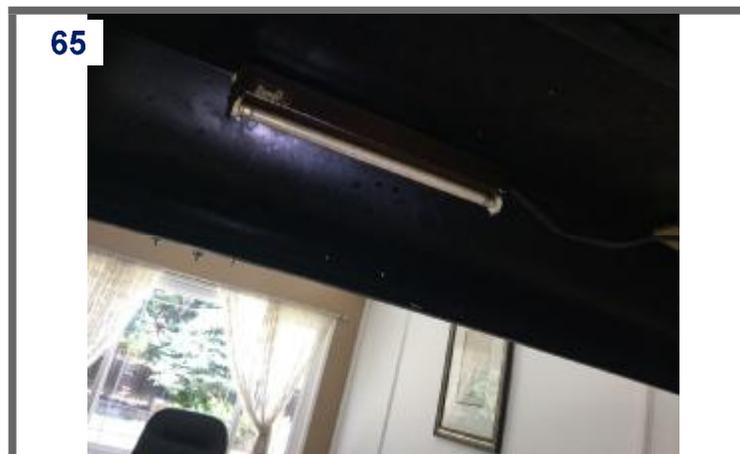
65

Stove vent light not operational. (2)

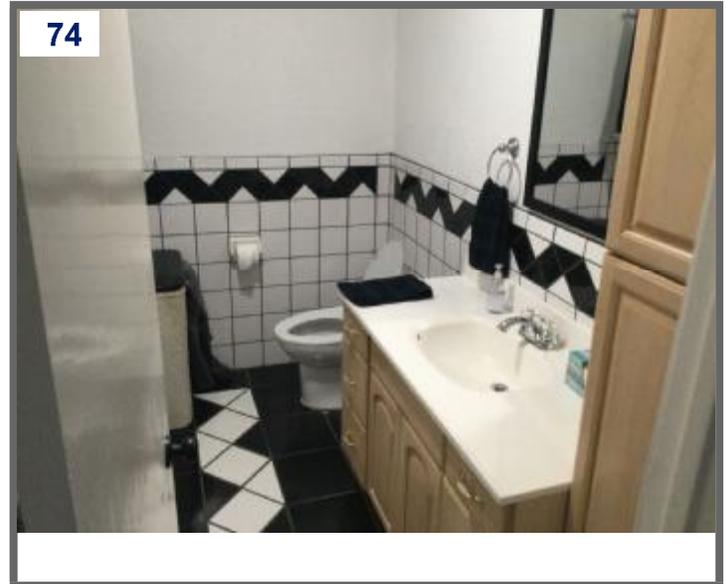
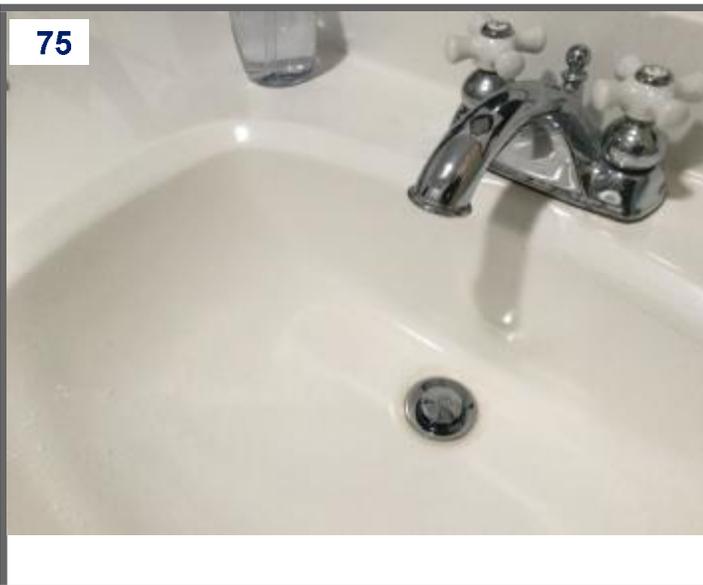
See Photo # 74,75 Water pressure too high, faucet spout is missing pressure reduction ring. (2)

74
Water pressure too high, faucet spout is missing pressure reduction ring. (2)

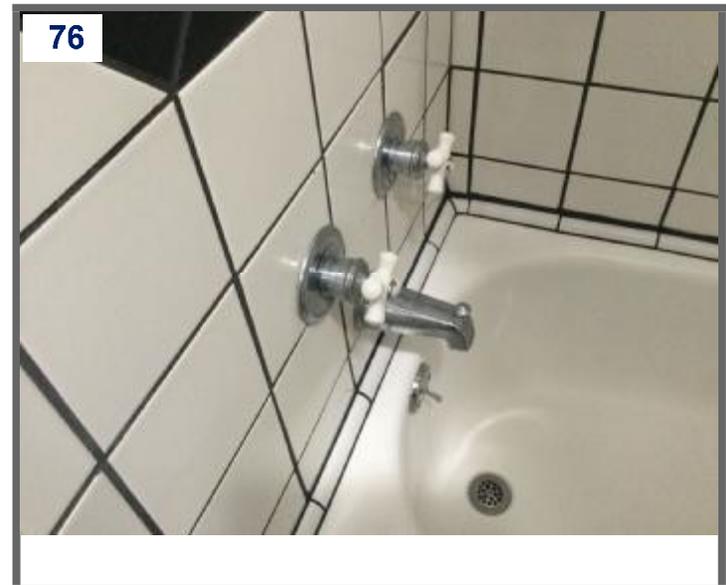
76
Hot water faucet handle is not operational. (2)

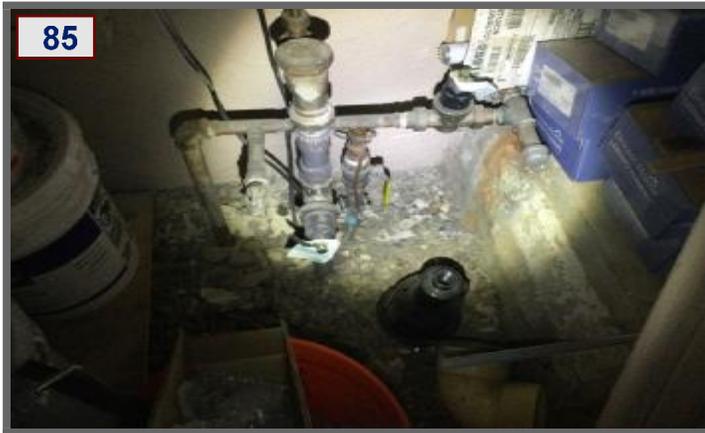
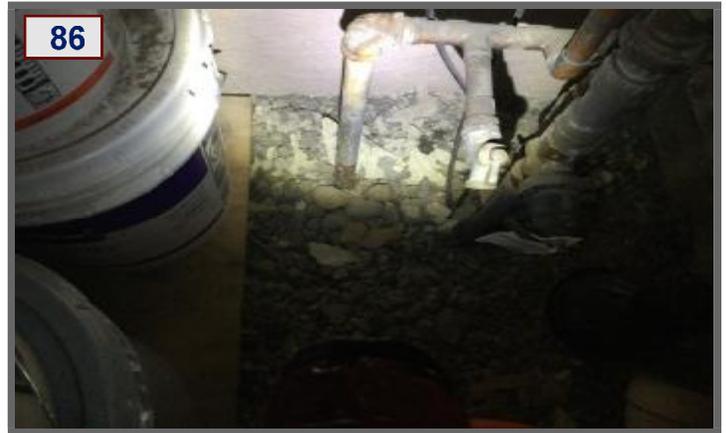
Supply Line: Supply pipes are replaced with copper, at some areas, unable to determine the age of lines, ask of seller when the pipes were replaced. (2)

Some galvanized pipe are corroded, unable to determine where this pipe goes. (2)

Supply Line: Supply pipes are replaced with copper, at some areas, unable to determine the age of lines, ask of seller when the

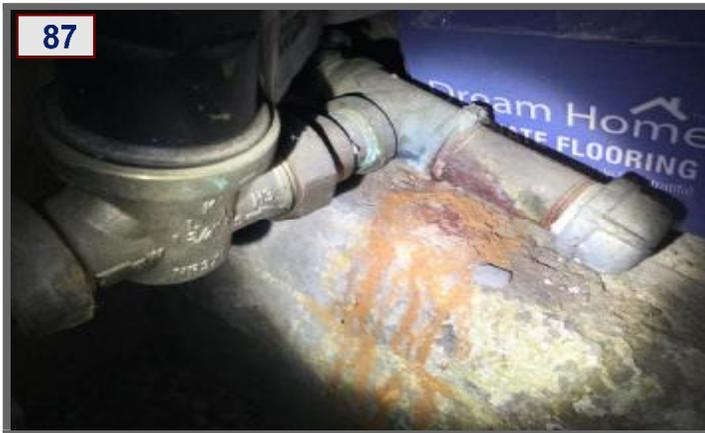
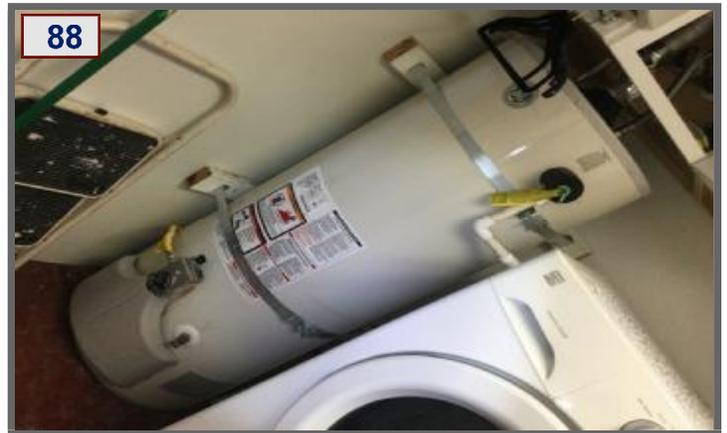
This galvanized connection will leak at any time. (2)

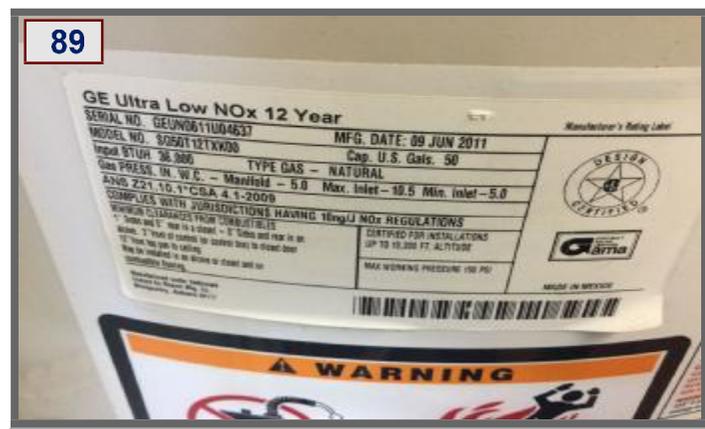
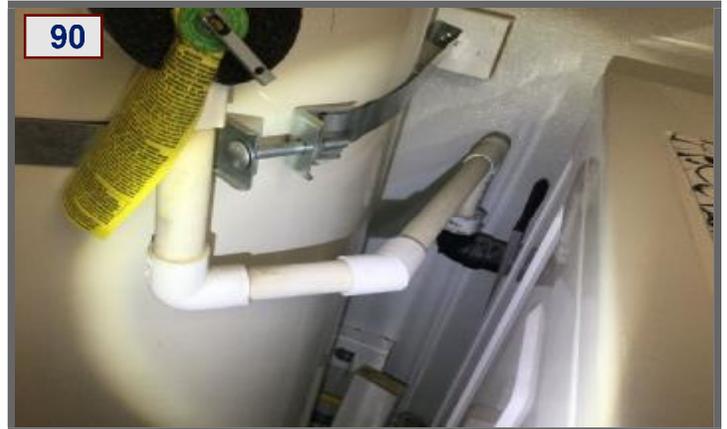
Water Heater: (TPR) Pressure / Temperature Relief Valve Pipe, the pipe is not piped down to floor or to exterior, needs repair immediately.

Safety Hazard. (2)

Water Heater: (TPR) Pressure / Temperature Relief Valve Pipe, the pipe is not piped down to floor or to exterior, needs repair immediately. Safety Hazard. (2)

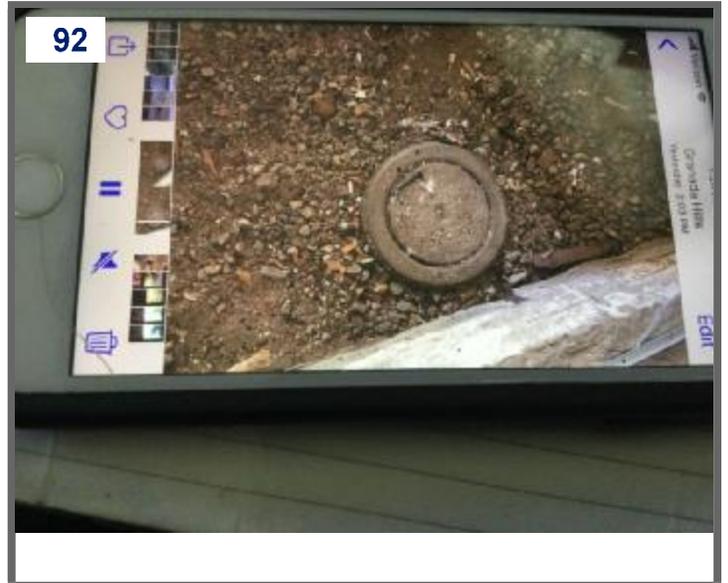
92

1st Sewer pipe clean out is located in garage, this is ABS 47 ft long to outside sidewalk 2nd clean out, pipe is clean not roots or cracks. (2)

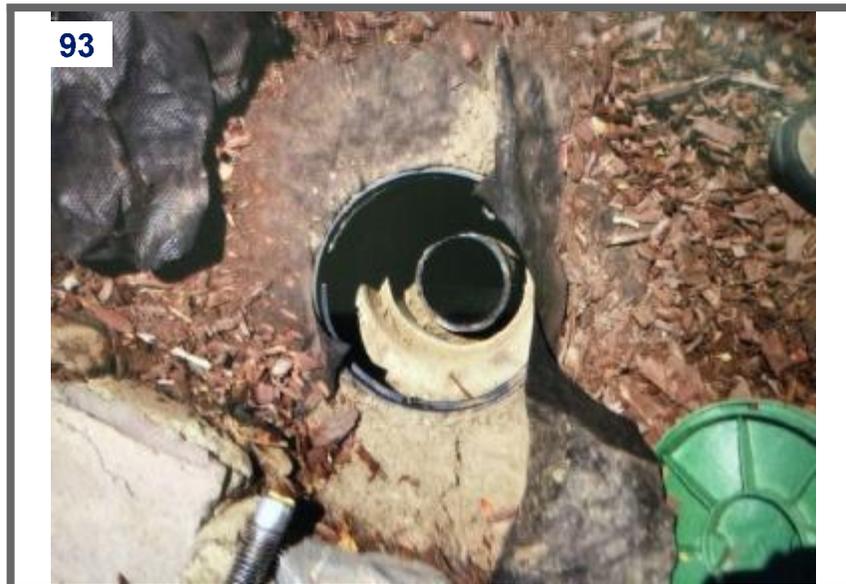
93

Sewer pipe at sidewalk is clay type pipe to city connection, approx 35 ft to city connection, no tree roots or cracked / opened areas. (2)

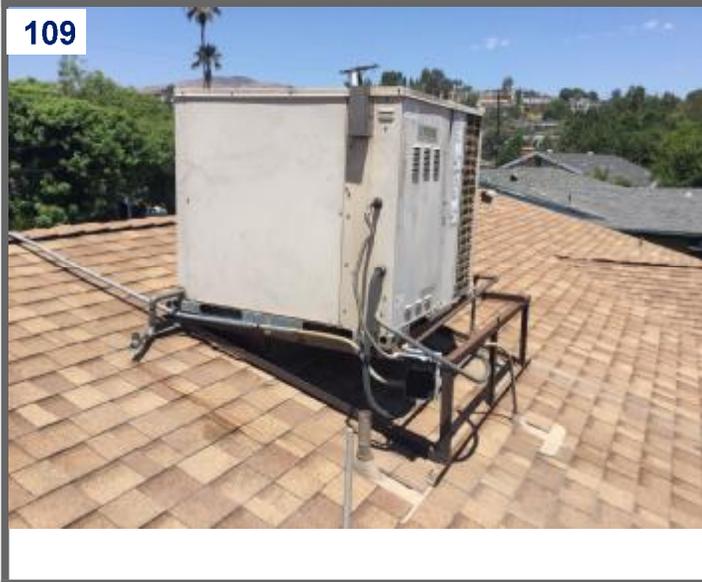
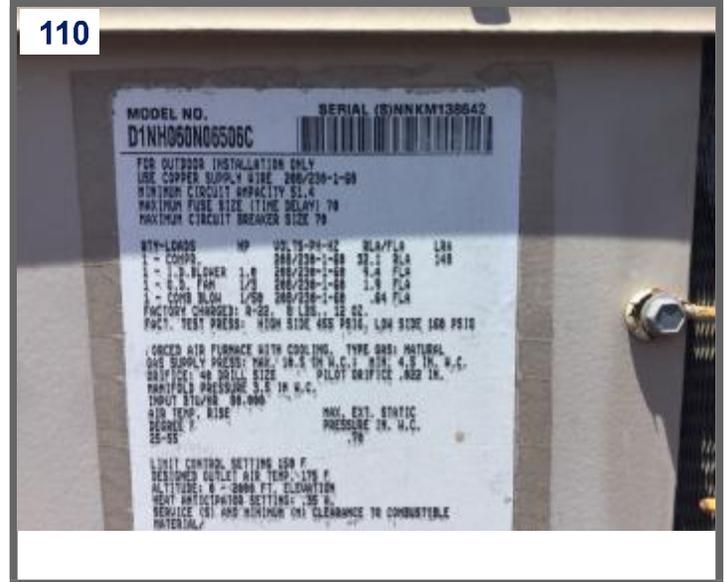
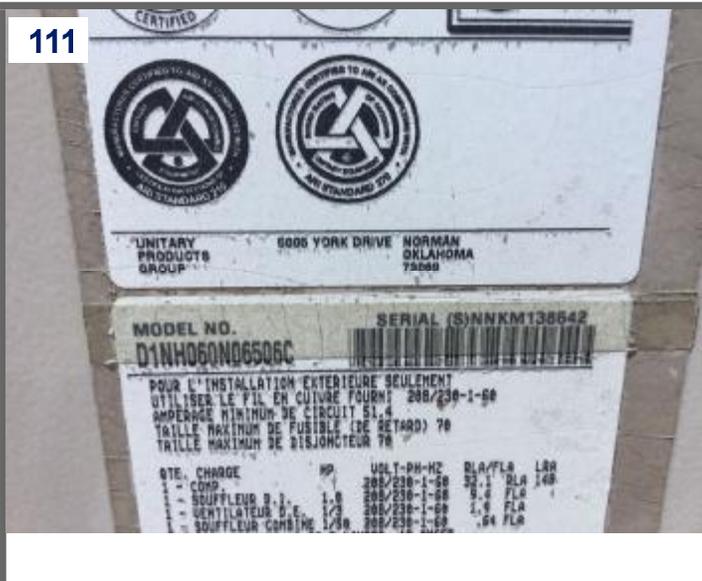
York Unitary Product Group manufactures date is 2001. (2)
 Heating: Keep in mind the advanced age of the heating system.
 Unit is at or nearing the end of it's expected useful life span.
 Budget for replacement in the near future. (2)

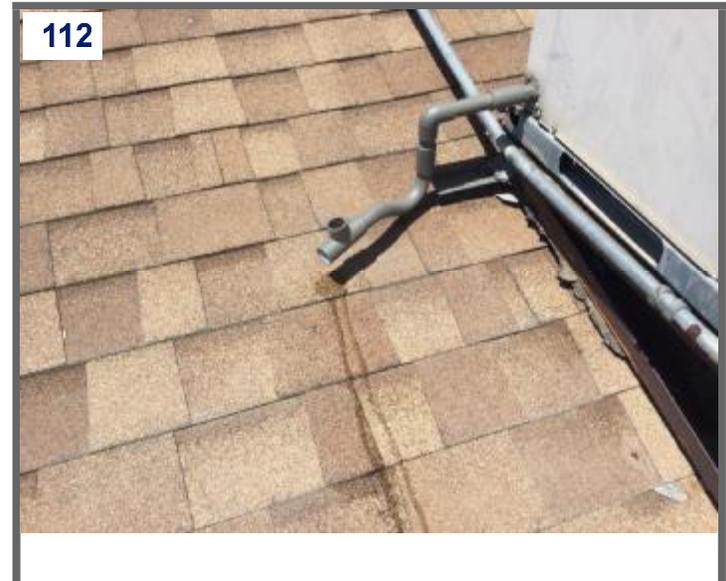
Condensation drain pipe is leaking. (2)
 Ask sellers for service history of heating and cooling units, I would recommend having units serviced cleaned and the the refrigerant level checked to insure optimum performance. (2)

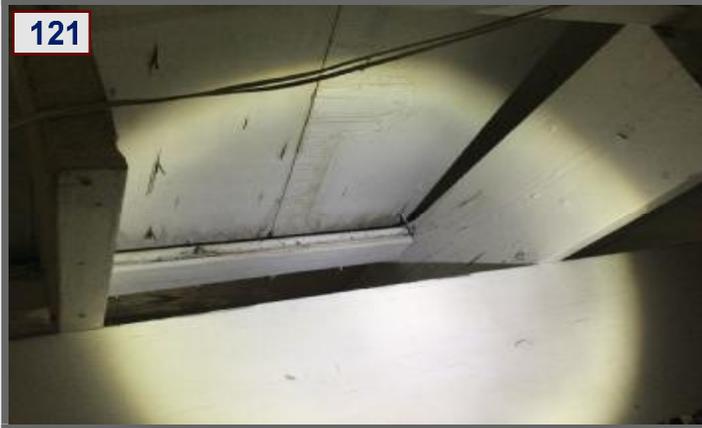
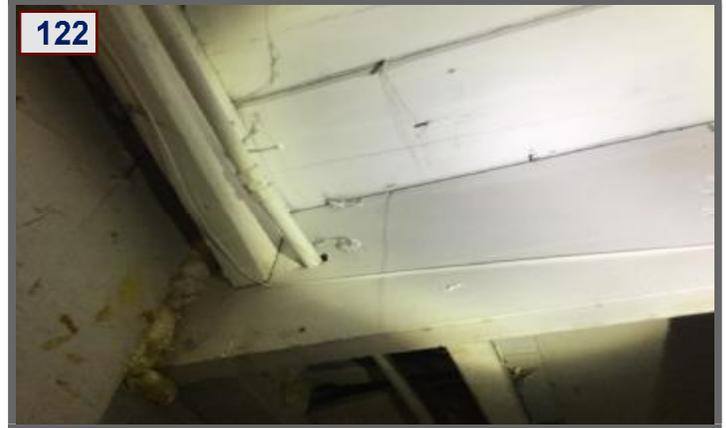
Ceiling has stains from past leaks, dat at time of inspection. (2)

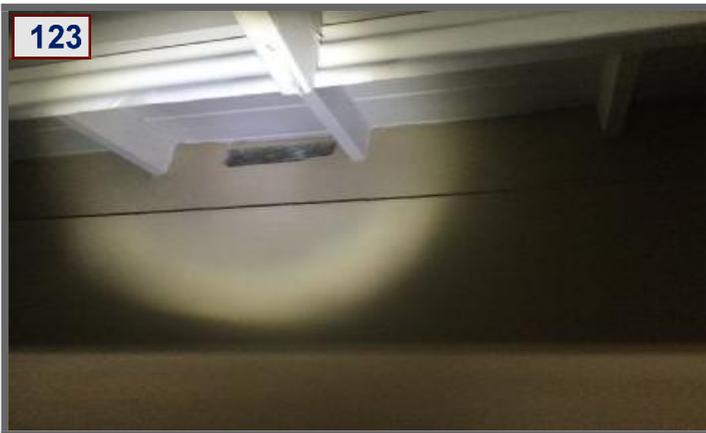
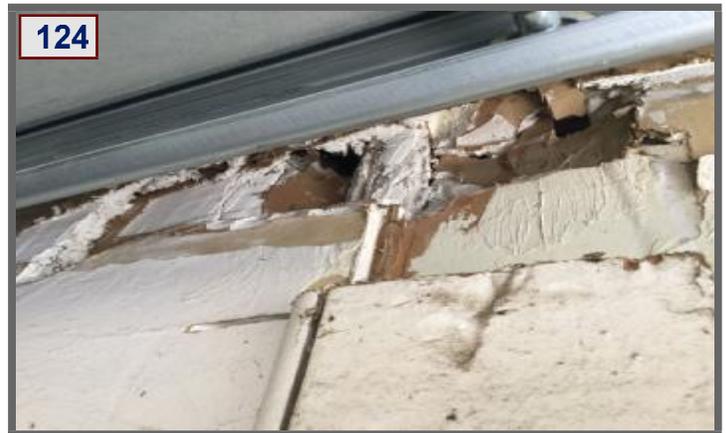
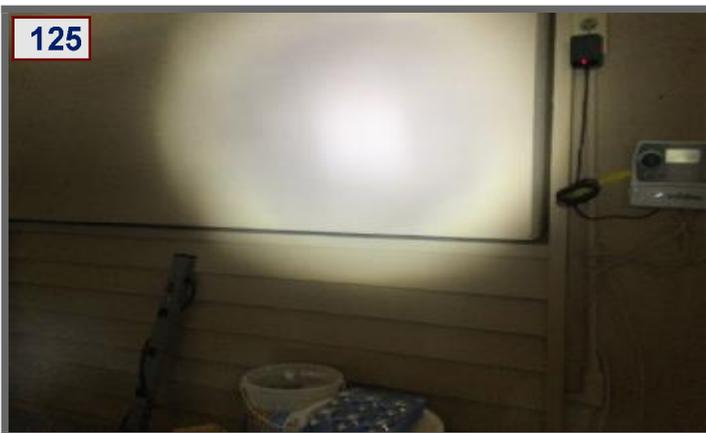
Fire Wall: Fire integrity is compromised by holes / gaps at several areas, missing firewall. (2)

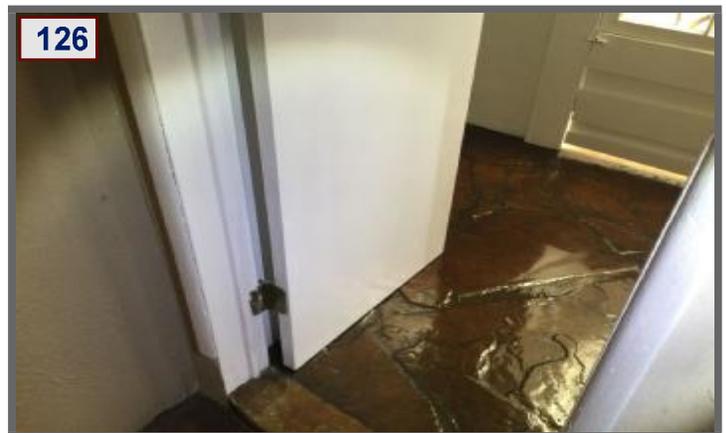
Fire Door: Door to living space does not appear to be solid core / a listed fire door, safety hazard. (2)
